**KOMITE NASIONAL KESELAMATAN TRANSPORTASI
REPUBLIC OF INDONESIA**

Aircraft Serious Incident Investigation Report

PT. Nusa Flying International

Cessna 172P; PK-NIZ

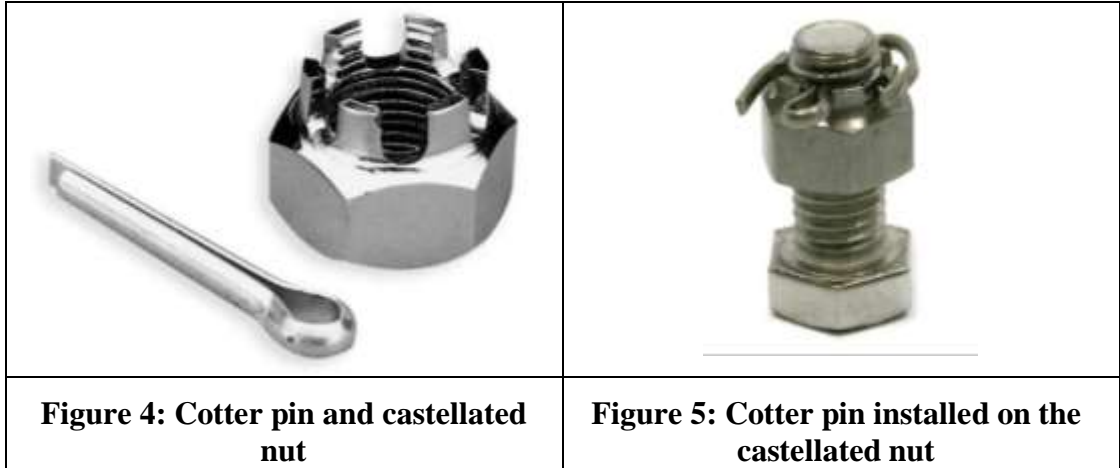
The cotter pin usually used with castellated nut where the head of the nut has radial slots aligned with one of the radial holes in the bolt. The pin is a loose fit in the hole and is kept in place by spreading the ends as shown on the figure 5.

The Cotter pin in Cessna 172 family as listed in the Illustrated Part Catalogue with part number MS24665 was made of carbon steel or corrosion resistant steel.
