**KOMITE NASIONAL KESELAMATAN TRANSPORTASI
REPUBLIC OF INDONESIA**

Aircraft Accident Investigation Report

Pilatus Porter PC-6, PK-BVM

Ilaga Airport

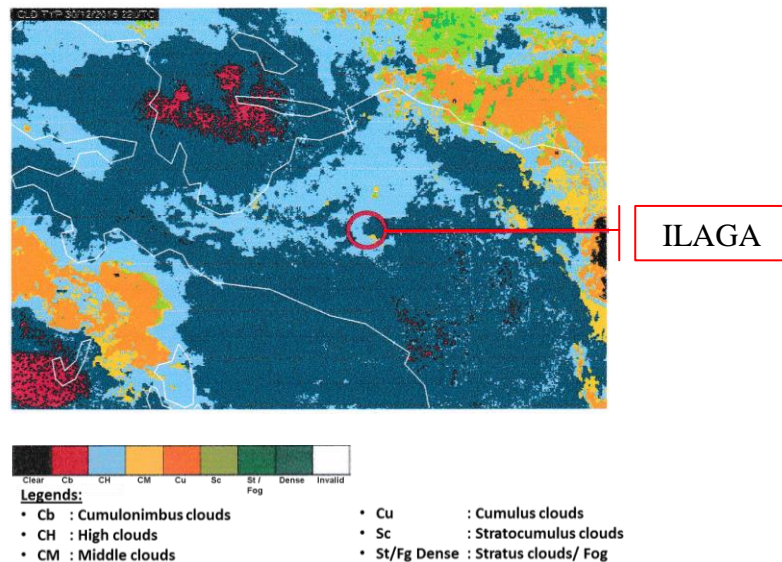
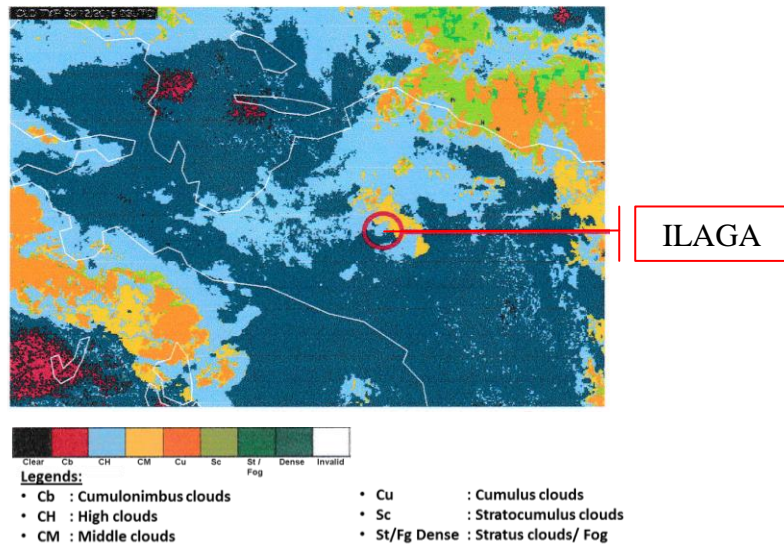
Figure 4: Satellite image at 2300 UTC

The following satellite images were provided by *Badan Meteorologi Klimatologi dan Geofisika* (BMKG – Bureau of Meteorology, Climatology and Geophysics) at 2200 UTC and 2300 UTC (figure 3 and 4). The images indicated a development of middle, and Cumulus clouds⁸ around Ilaga during the occurrence flight.
