**KOMITE NASIONAL KESELAMATAN TRANSPORTASI
REPUBLIC OF INDONESIA**

Aircraft Accident Investigation Report

Batik Air Indonesia and TransNusa Aviation Mandiri

Boeing 737-800 (PK-LBS) and ATR 42-600 (PK-TNJ)

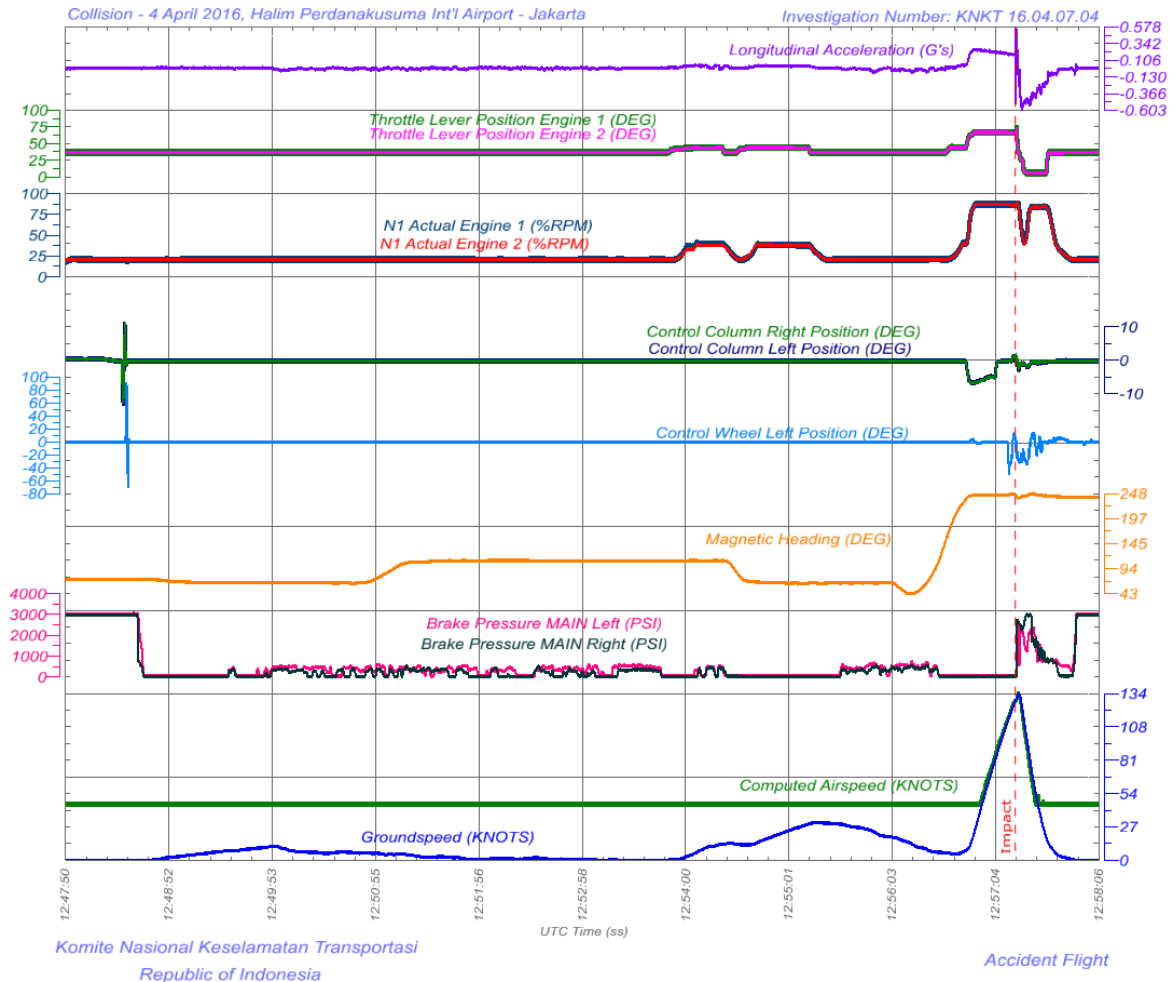
Figure 9: The graph of significant parameters recorded by the FDR from taxi until stop

- 12:48:43 UTC, the ground speed started to increase, indicating that the aircraft started to taxi;
- 12:50:53 UTC, the aircraft heading started to change to heading approximately 110°;
- 12:53:08 UTC, the ground speed 0;
- 12:53:55 UTC, the engine power (N1) increased, ground speed increased
- 12:54:35 UTC, the aircraft heading changed to 065° and groundspeed increased continuously up to 30 knots;
- 12:56:03 UTC, the ground speed decreased and aircraft heading changed to the left and thereafter to the right to heading 248°;
- 12:56:55 UTC, just before reached steady heading of 248°, the throttle levers, the N1 and the aircraft speed increased.

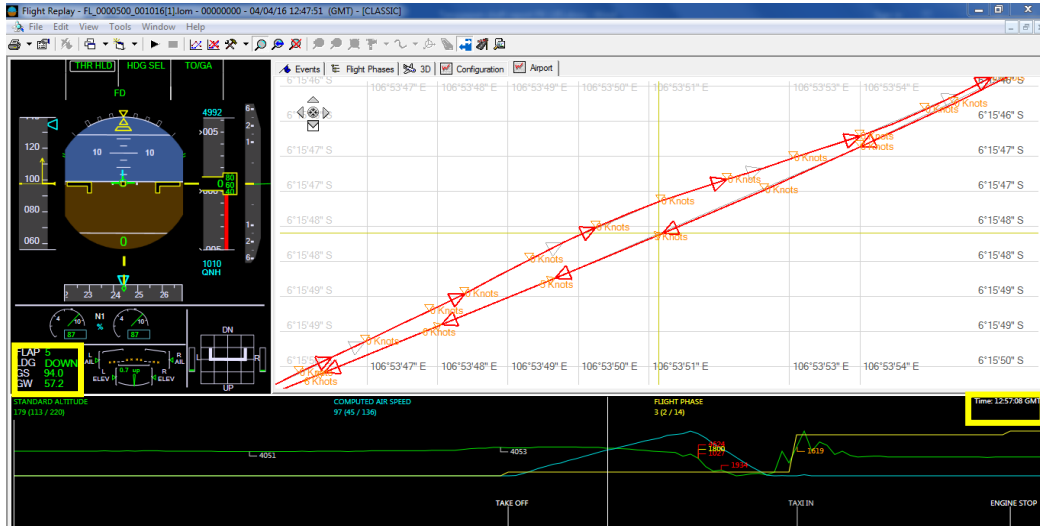
Figure 19: The FOQA data processed using the AirFASE® system

- The TO/GA was initiated at 12:56:48 UTC and, based on the data of latitude and longitude, Batik Air calculated the position was approximately 70 meters before the threshold;
- The SIC stated that he saw something at 12:57:08 UTC and the Ground Speed (GS) was 94 Knots;
- The impact position was 916 meters from the runway threshold.

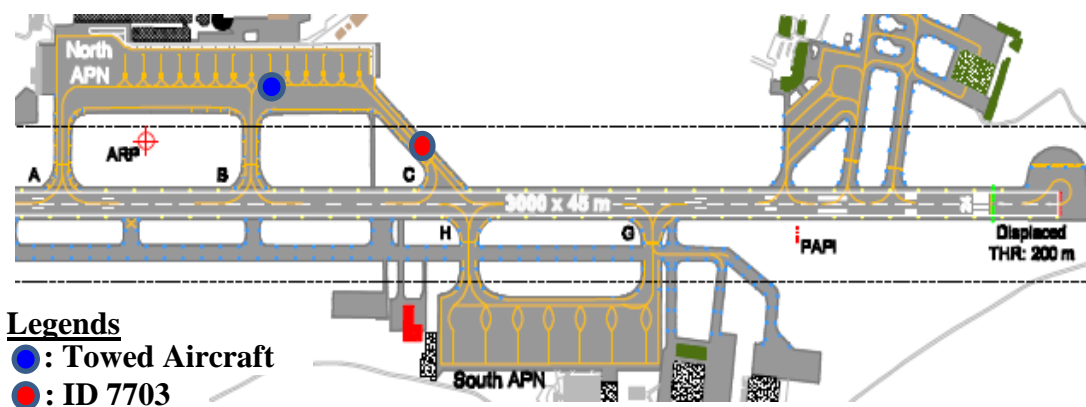
Figure 22: Illustration of the aircraft position at 1253 UTC

The distance between parking stand B-1 to B-9 was approximately 330 meters, it can be assumed that the towed aircraft was abeam parking stand B-9 was at about 1253 UTC.

At about 1253 UTC or while towed aircraft position abeam parking stand B-9, the towing car driver was instructed to expedite the towing and to follow ID 7703. The instruction was acknowledged by towing car driver.

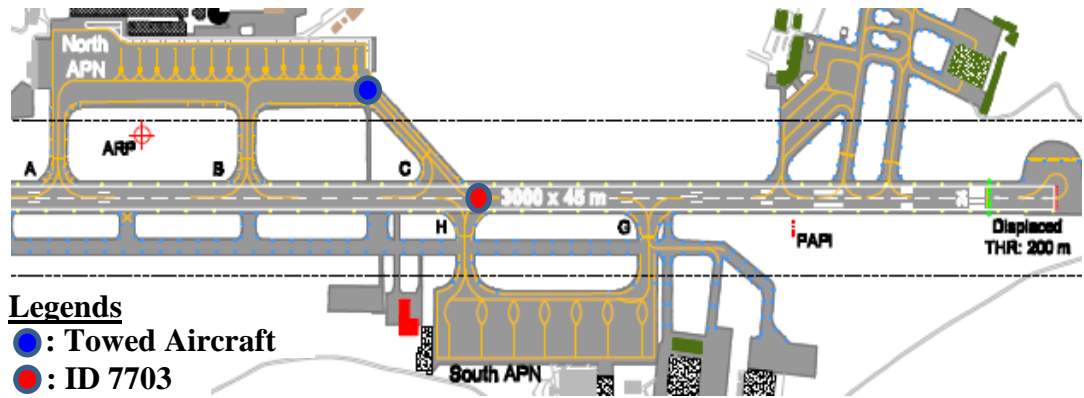
Figure 23: Illustration of the aircraft position at 1254 UTC

The distance between parking stand B-1 to the beginning taxiway C was about 530 meters, it can be assumed that at about 1254 UTC, the towed aircraft was about to enter taxiway C.

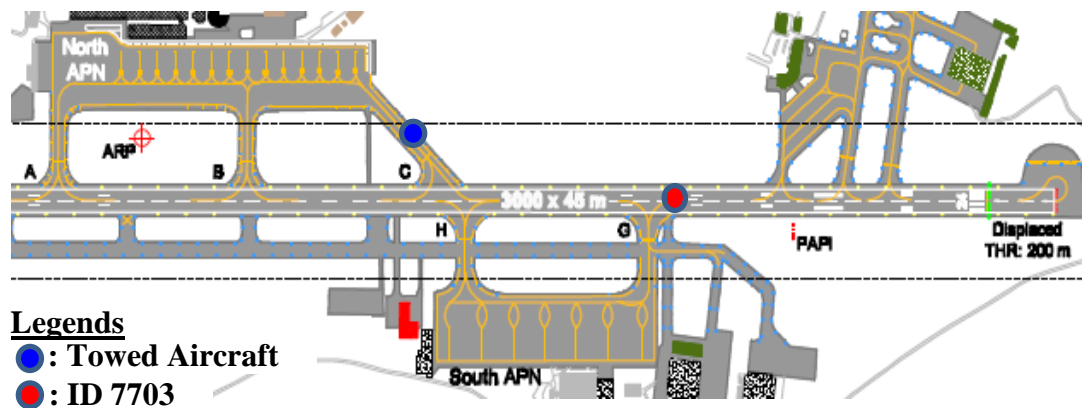
Figure 24: Illustration of the aircraft position at 1255 UTC

The length of taxiway C was about 210 meters, it can be assumed that at about 1255 UTC, the towed aircraft was on the middle of taxiway C.

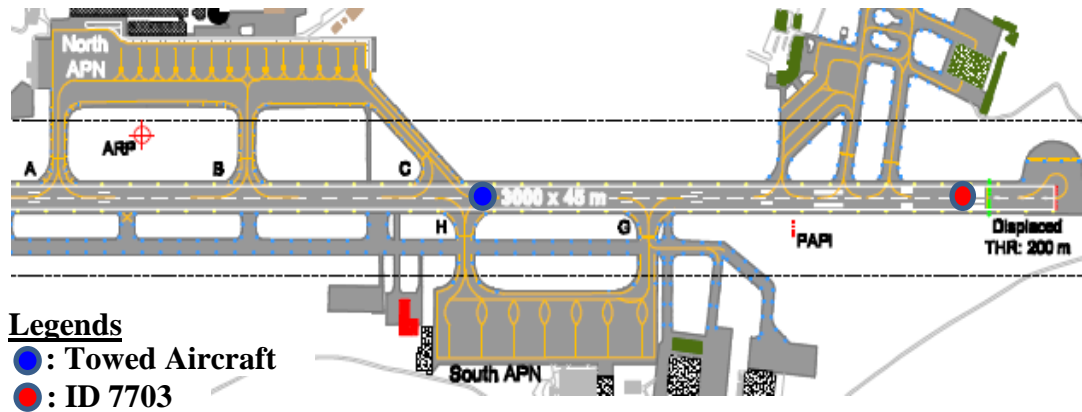
Figure 25: Illustration of the aircraft position at 1256 UTC

The distance of the middle taxiway C to the runway centerline was approximately 190 meters. Assumed that the towed aircraft on taxiway C at 1255 UTC, therefore when the ID 7703 was initiating the takeoff, the towed aircraft was on the runway center line.

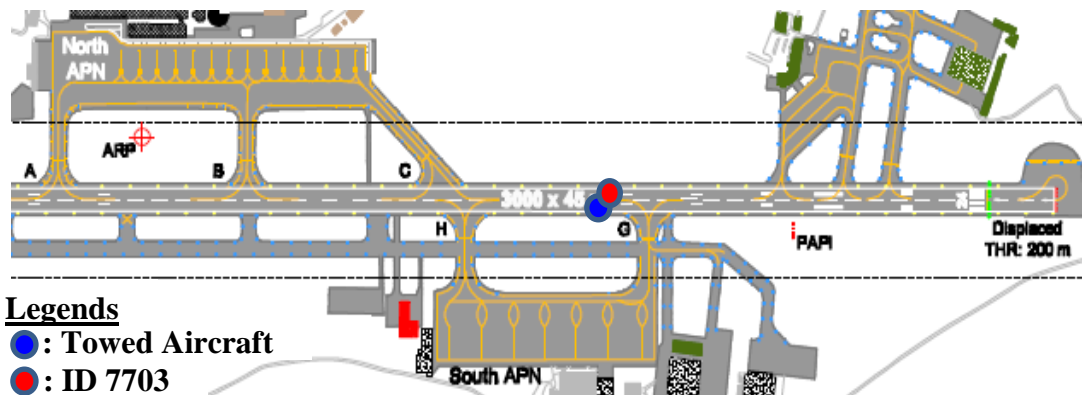
Figure 26: Illustration of the aircraft impact position at 1257 UTC

The distance between intersection taxiway C to the impact point was approximately 210 meters. Refer to the previous assumption that the towed aircraft on the runway centerline at 1256 UTC, therefore, at 12:57:16 UTC, the towed aircraft had reached the impact point.
