**KOMITE NASIONAL KESELAMATAN TRANSPORTASI
REPUBLIC OF INDONESIA**

FINAL
KNKT.16.06.21.04

Aircraft Accident Investigation Report

**Nusa Flying School
Cessna 172P; PK-NIV
Demak, Central Java
06°48.094'S, 110°35.011'E
Republic of Indonesia
20 June 2016**

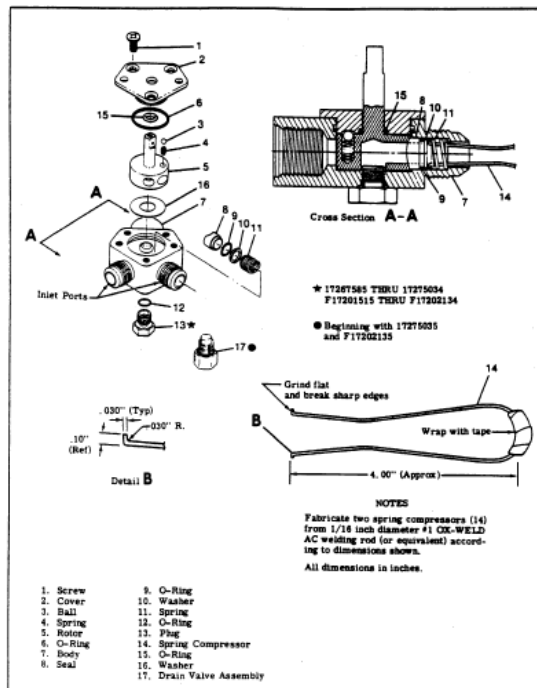
Figure 7: Fuel Selector Valve and Spring Compressor

12-13. DESCRIPTION. A four positions fuel selector valve is located beneath the floorboard just aft and slightly to the left of the pedestal structure. A shaft links the valve to a handle mounted on the pedestal structure. The positions of the handle are labeled "OFF, LEFT, BOTH and RIGHT".

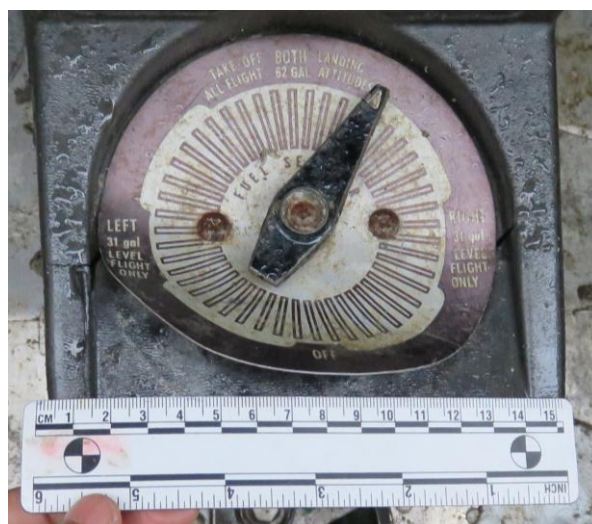
Figure 9: Fuel selector label positions

KNKT conducted the observation of fuel selector valve in KNKT facility to define the fuel flow related to the selection of the selector valve handle. The fuel selector valve handle can be rotated in any direction. At each selected label, there was detent on the selector to make sure the proper selection of the valve.
