**KOMITE NASIONAL KESELAMATAN TRANSPORTASI
REPUBLIC OF INDONESIA**

Aircraft Serious Incident Investigation Report

Malaysia Airlines

Boeing 737-800; 9M-MXH

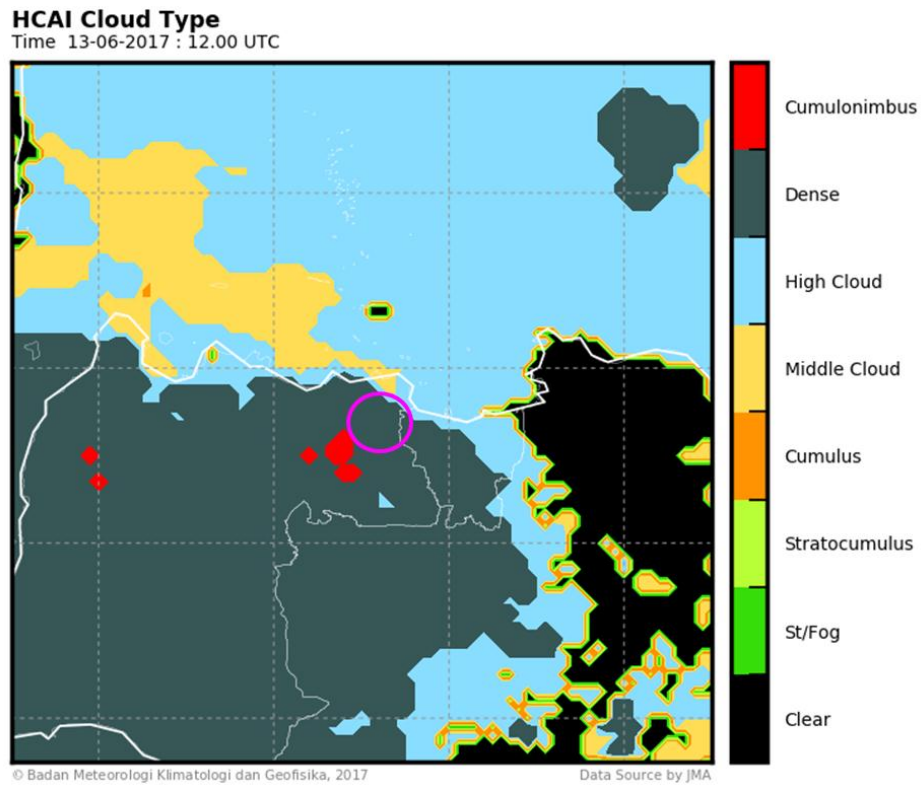
Figure 2: Satellite image at 1200 UTC

The following satellite images were provided by the BMKG at 1200 UTC, 1300 UTC and 1400 UTC. The images indicated that the condition over Jakarta (purple circle) was on dense condition.
