**KOMITE NASIONAL KESELAMATAN TRANSPORTASI  
REPUBLIC OF INDONESIA**

**Aircraft Accident Investigation Report**

**Boeing 737-300; PK-CJC**

**Rendani Airport, Manokwari, West Papua**

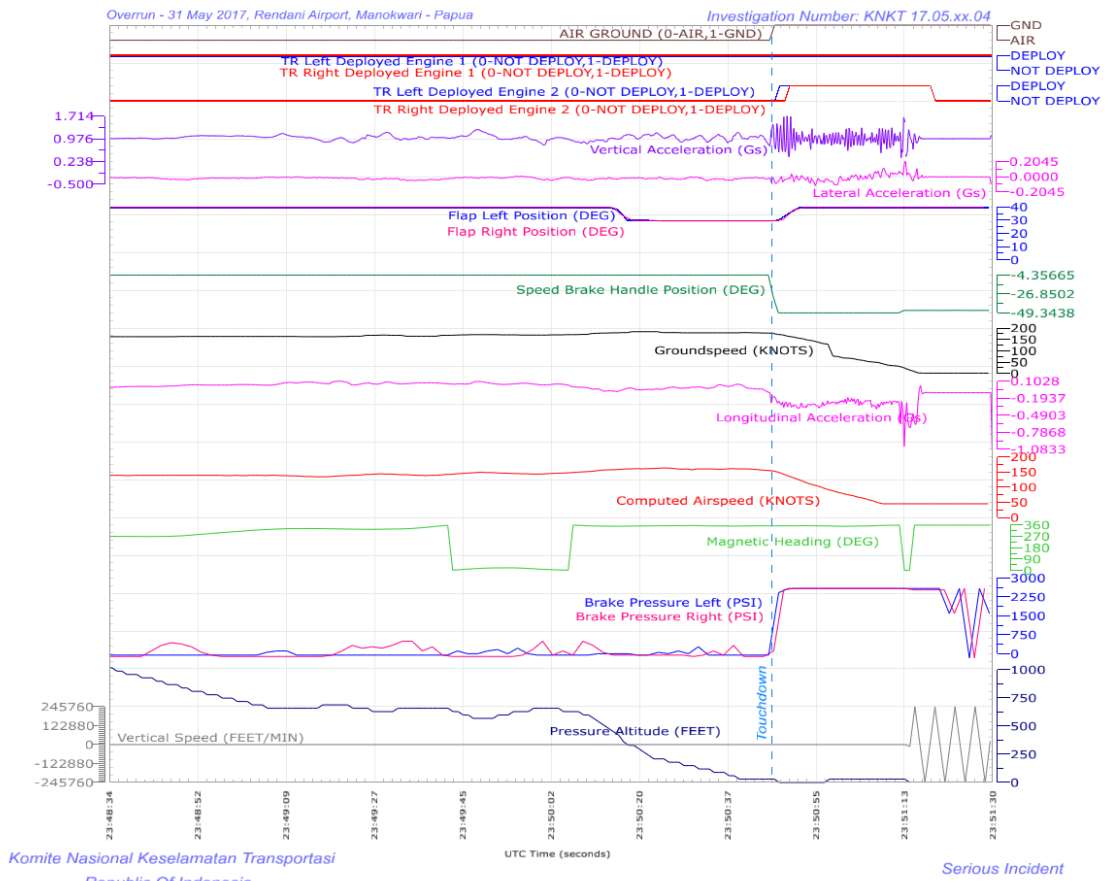
**Figure 8: The significant FDR parameters**

Few of FDR parameters from approximate 350 feet prior the aircraft landing on runway 35 were downloaded and showed in the figure below.
