**KOMITE NASIONAL KESELAMATAN TRANSPORTASI  
REPUBLIC OF INDONESIA**

## **KNKT.17.04.10.04**

### **Aircraft Accident Investigation Report**

**Cessna 208; PK-FSO**

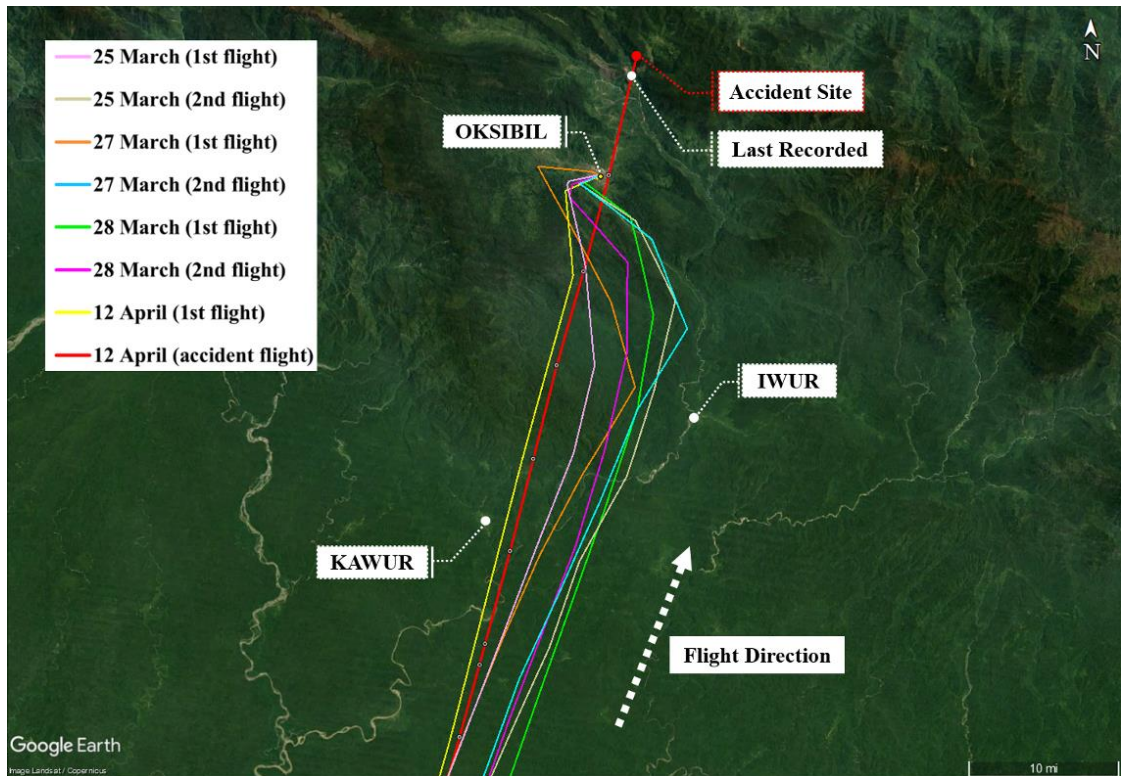
**Figure 10: The recorded flight tracks superimposed with Google Earth**

The aircraft wreckage was found at altitude approximately 7,100 feet on ridge of Anem Mountain, which located at about 7 Nm north of Oksibil with coordinate 04°47.79' S; 140°39.77' E. The distance between the last recorded position in the Spydertracks to the accident site was about 1 Nm (see figure 2).
