**KOMITE NASIONAL KESELAMATAN TRANSPORTASI
REPUBLIC OF INDONESIA**

KNKT.17.02.06.04

Aircraft Serious Incident Investigation Report

Boeing 737-800; PK-GNK

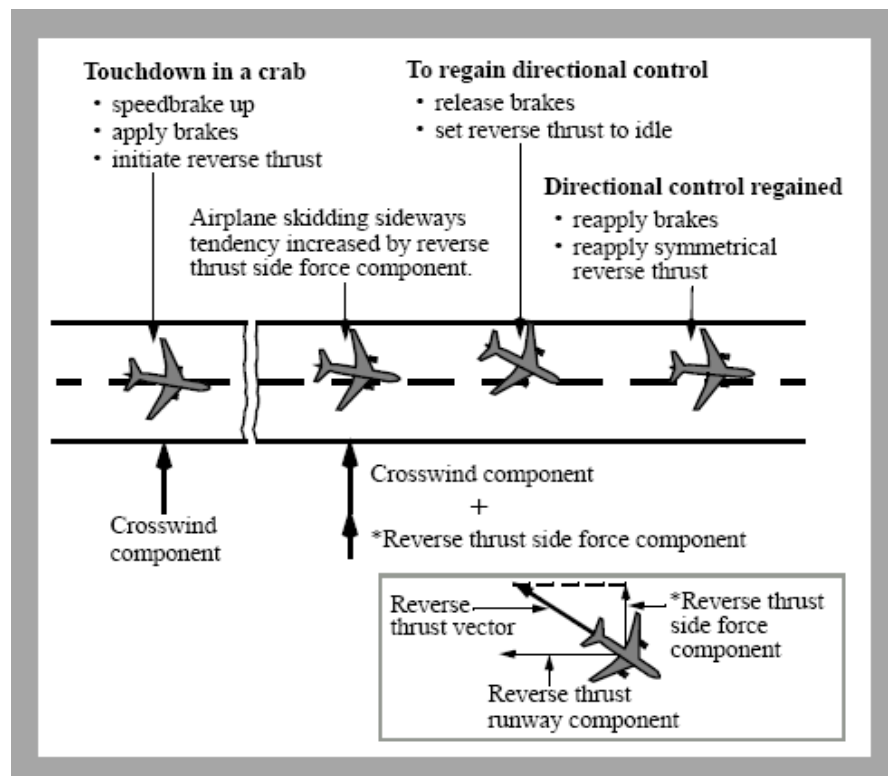
Reverse Thrust Operation and Crosswind (all engine) (6.43)

This figure shows a directional control problem during a landing rollout on a slippery runway with a crosswind. As the airplane starts to weathervane into the wind, the reverse thrust side force component adds to the crosswind component and drifts the airplane to the downwind side of the runway. Also, high braking forces reduce the capability of the tires to corner.

To correct back to the centerline, release the brakes and reduce reverse thrust to reverse idle. Releasing the brakes increases the tire-cornering capability and contributes to maintaining or regaining directional control. Setting reverse idle reduces the reverse thrust side force component without the requirement to go through a full reverser actuation cycle. Use rudder pedal steering and differential braking as required, to prevent over correcting past the runway centerline. When
