**KOMITE NASIONAL KESELAMATAN TRANSPORTASI
REPUBLIC OF INDONESIA**

Aircraft Accident Investigation Report

PT. Batik Air

Boeing 737-800; PK-LBY

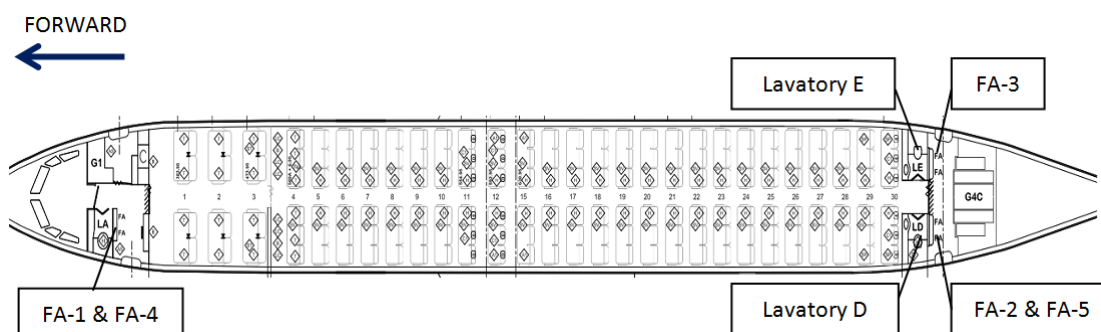
The FA-1 and FA-4 positions were in forward area and the FA-2, FA-3 and FA-5 were in aft area.

FA-1 and FA-4 immediately seated on their seat in the forward galley then FA-4 performed the announcement of weather encounter. FA-3 took seat immediately on a vacant passenger seat then fastened the seatbelt. FA-2 and FA-5 seated on their seat on the aft cabin and did not use seatbelt at that time of turbulence. FA-2 was unable to reach the interphone to perform the weather announcement.
