KOMITE NASIONAL KESELAMATAN TRANSPORTASI REPUBLIC OF INDONESIA

FINAL KNKT.18.04.10.04

Aircraft Accident Investigation Report

PT Whitesky Aviation Helicopter Bell 429, PK-WSX Morowali, Sulawesi Tengah Republic of Indonesia 20 April 2018

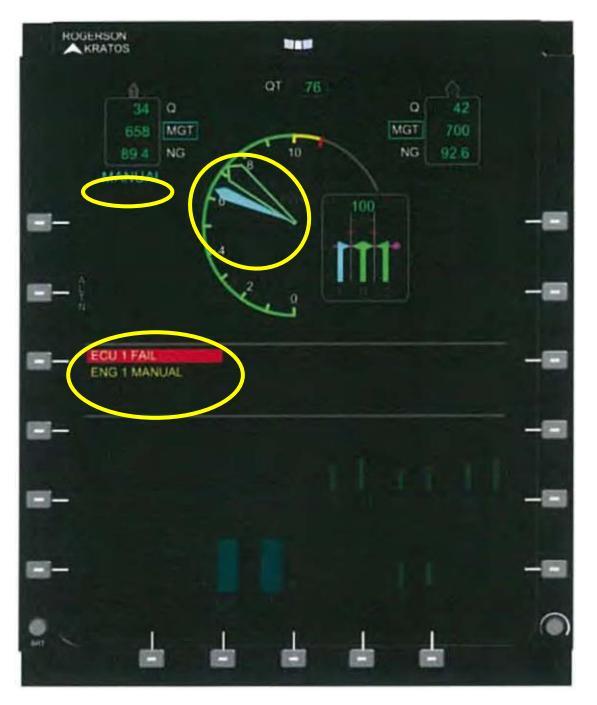
Figure 6: The indication of failure EEC or ECU of engine 1

The EEC failure is indicated on the Crew Alerting System (CAS) by the message of 'ECU # FAIL' (the '#' represents the number of the respective EEC failure) and the 'MANUAL' message displays below the digital readout of engine parameters of the respective engine. In the same time, the Power Situation Indicator (PSI) needle of affected engine turns color to cyan.

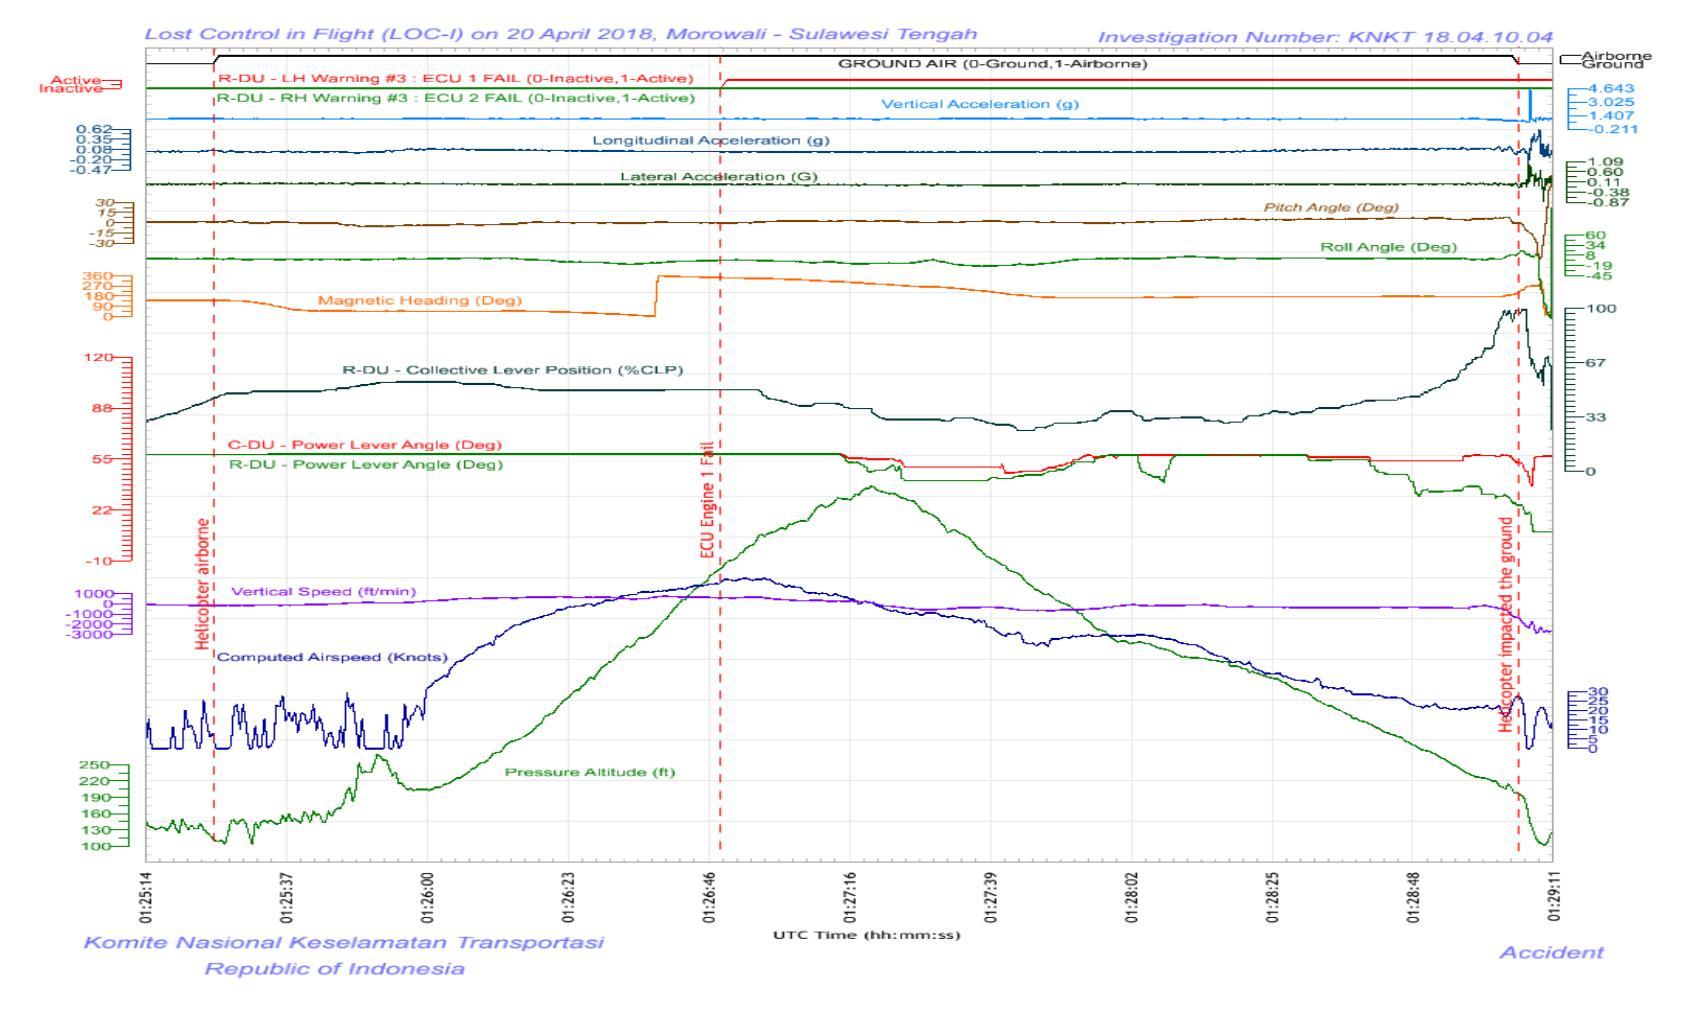
Figure 9: The FDR data of flight parameters

The FDR data represent on figure 9 showed the flight parameters and the figure 10 showed the engine parameters.

- 6. At 09:25:27 LT, the helicopter lifted off the ground and the pressure altitude recorded about 120 feet.
- 7. At 09:26:49 LT, the pressure altitude was about 600 feet, the ECU 1 Fail warning active and followed by the Master Warning light illuminated one second after.

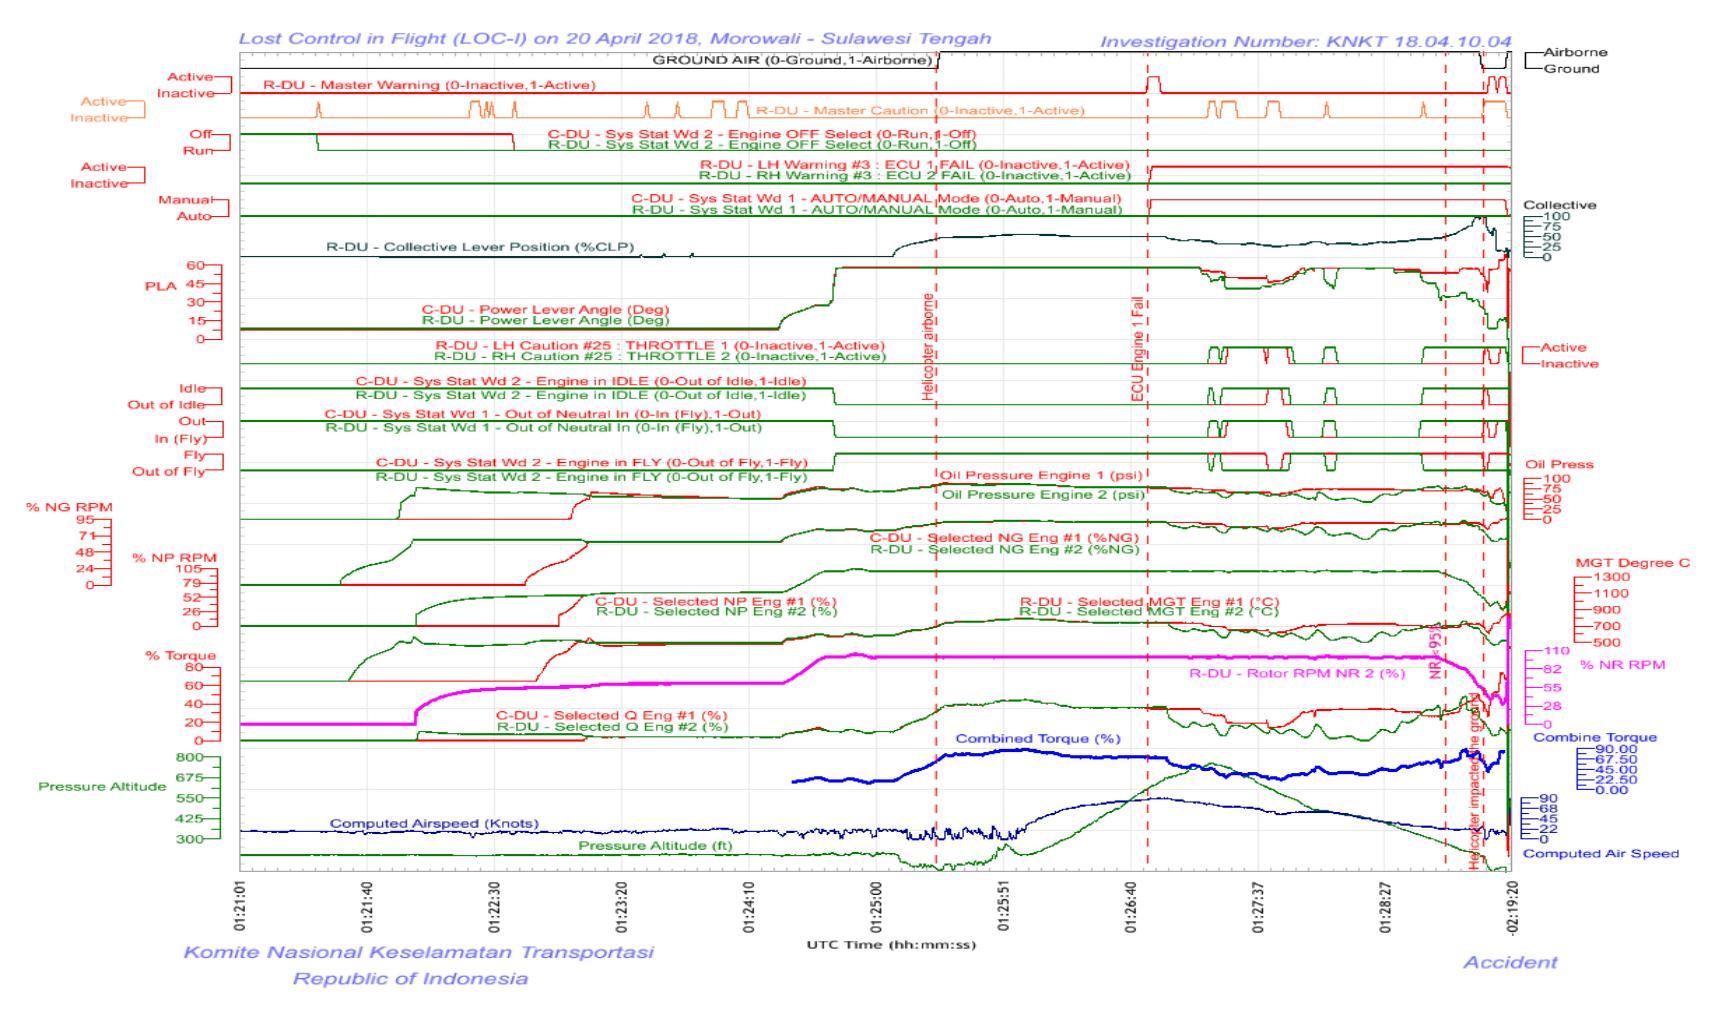
Figure 10: The FDR data of engine parameters

- 8. At 09:27:03 LT, the engine 2 torque, NG, and the engine temperature (MGT) consistently drop when the collective was moved down but the engine 1 parameter was not change. This condition occurred because the EEC engine 1 had fail led to the engine 1 NG RPM remain unchanged. Therefore, to maintain the NR rotation and to avoid any over speed of NG RPM, the EEC engine 2 (which was still in AUTO) automatically adjusted the torque and NG of engine 2.

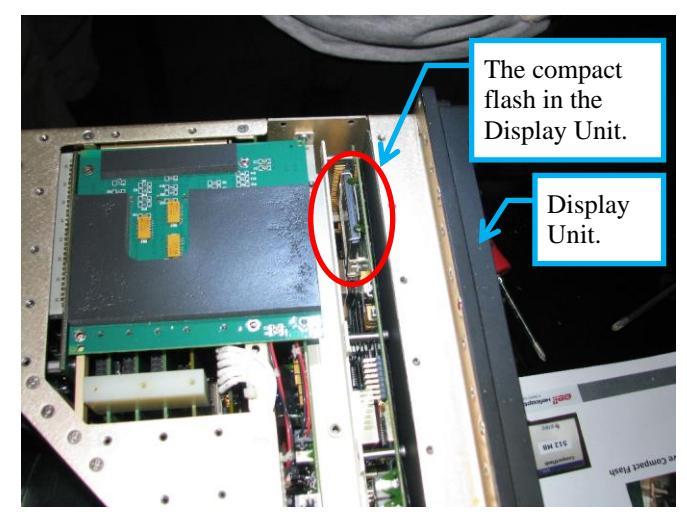
Figure 21: The compact flash in the Display Unit

The DUs contain a Display Unit Electronic Data Recorders (EDRs) which was stored in the compact flash card memory module. The compact flash which was installed in the DU is shown in the following figures.
