**KOMITE NASIONAL KESELAMATAN TRANSPORTASI
REPUBLIC OF INDONESIA**

Aircraft Serious Incident Investigation Report

PT. Spirit Avia Sentosa (FlyingSAS)

Cessna 208B, PK-FSL

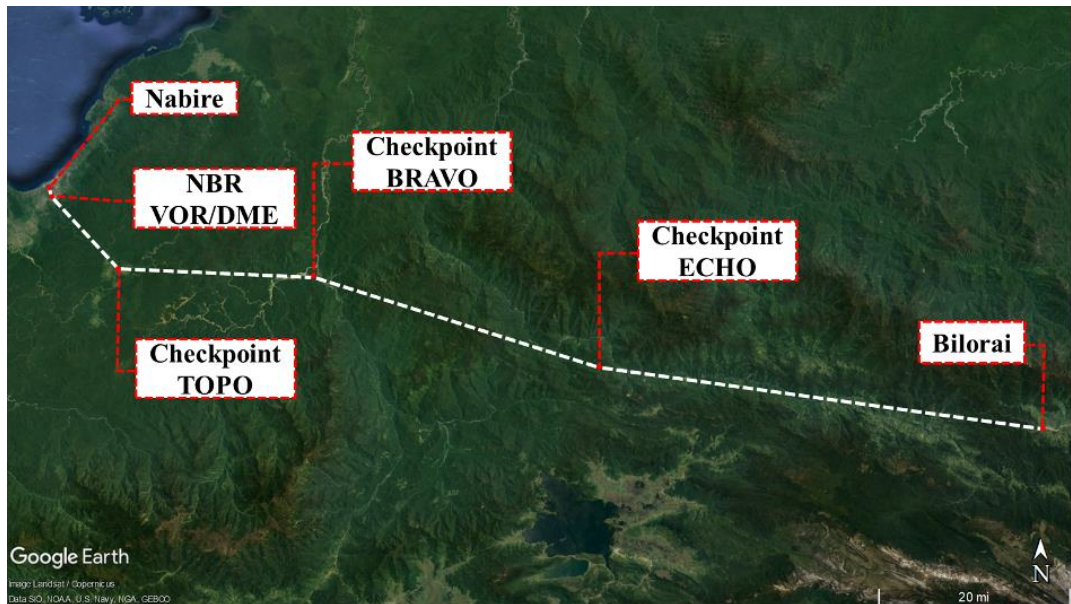
Figure 1: The flight plan route Bilorai to Nabire via checkpoint TOPO

At about 1415 LT on daylight condition, the aircraft departed Bilorai and cruised at altitude of 10,500 feet. At about 20 Nm before checkpoint BRAVO, which was about 40 Nm from NBR VOR/DME, the pilot started to descend with rate of descend about 500 fpm. The pilot noticed development of clouds along the route and decided to avoid the clouds by deviating to the right of the GPS route.

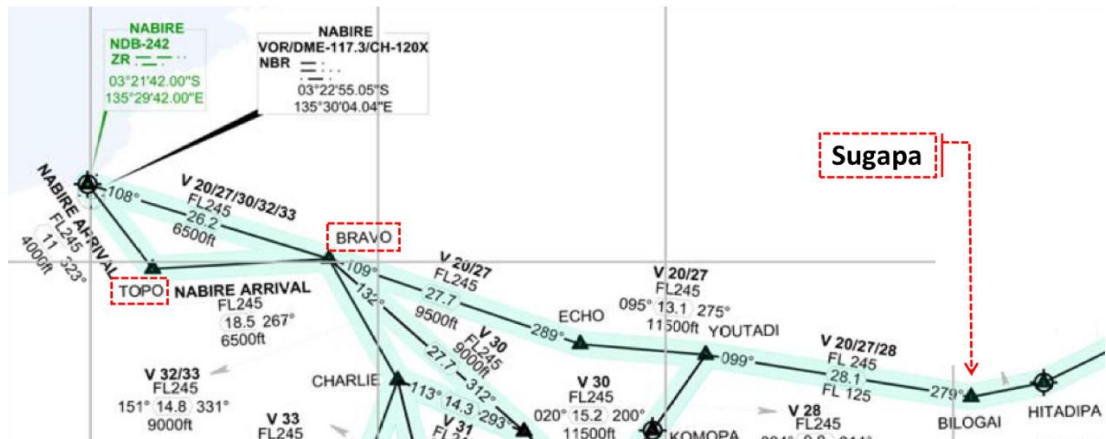
Figure 11: The VFR Route chart from Sugapa to Nabire or return

The NABIRE ARRIVAL route required pilot to fly toward check point TOPO with lowest altitude limit of 6,500 feet and then toward ZR NDB with lowest altitude limit of 4,000 feet. The VICTOR 20/27/30/32/33 route required to fly direct to ZR NDB with lowest altitude limit of 6,500 feet. The upper altitude limit for both routes were 24,500 feet.

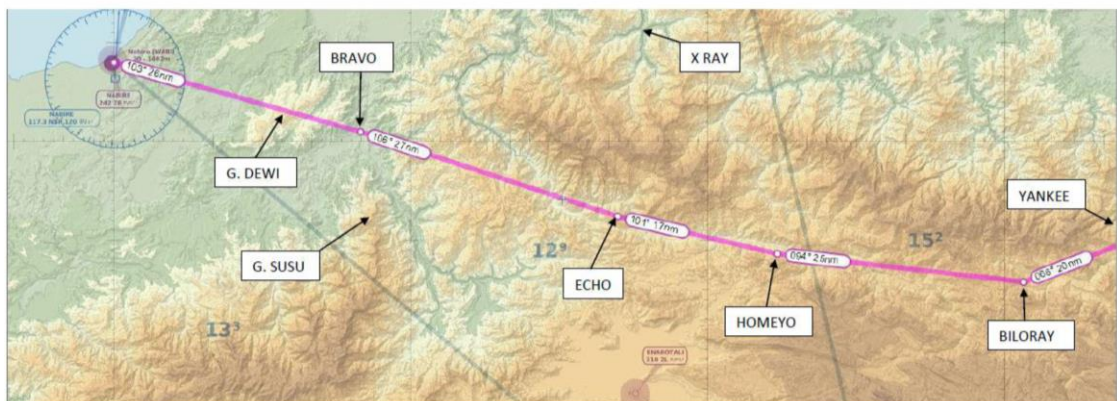
Figure 12: The VFR chart of Nabire – Sugapa and return

The FlyingSAS issued Route and Airport Instruction of Nabire, and Visual Flight Rules (VFR) Chart for route Nabire – Sugapa (Bilorai) and return (figure 12). These guidance were contained in the FlyingSAS Operation Manual (OM) – Part C.

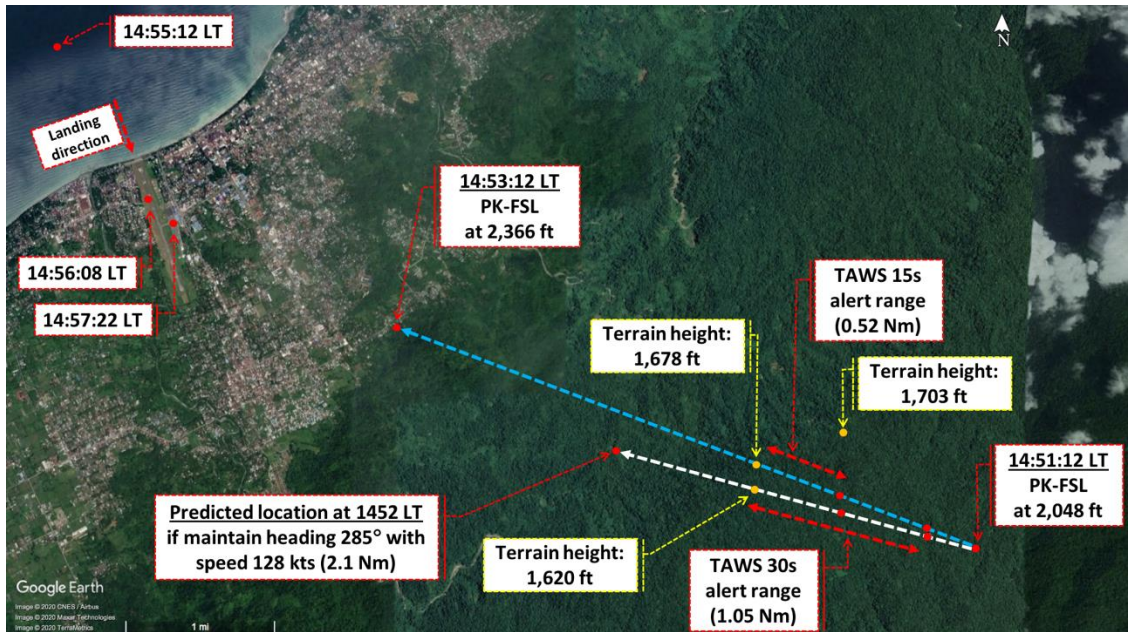
Figure 17: The estimated terrain location and GPWS alerts range

Using the formula S (distance) = V (speed) x t (time), if the aircraft speed was 128 knots, the 30 seconds of GPWS alert area would be at distance about 1,05 Nm, while the 15 seconds of GPWS alert area would be 0.52 Nm towards the estimated terrain locations. Both alert ranges should trigger the aural alert if the aircraft was descended at the same of the terrain height.

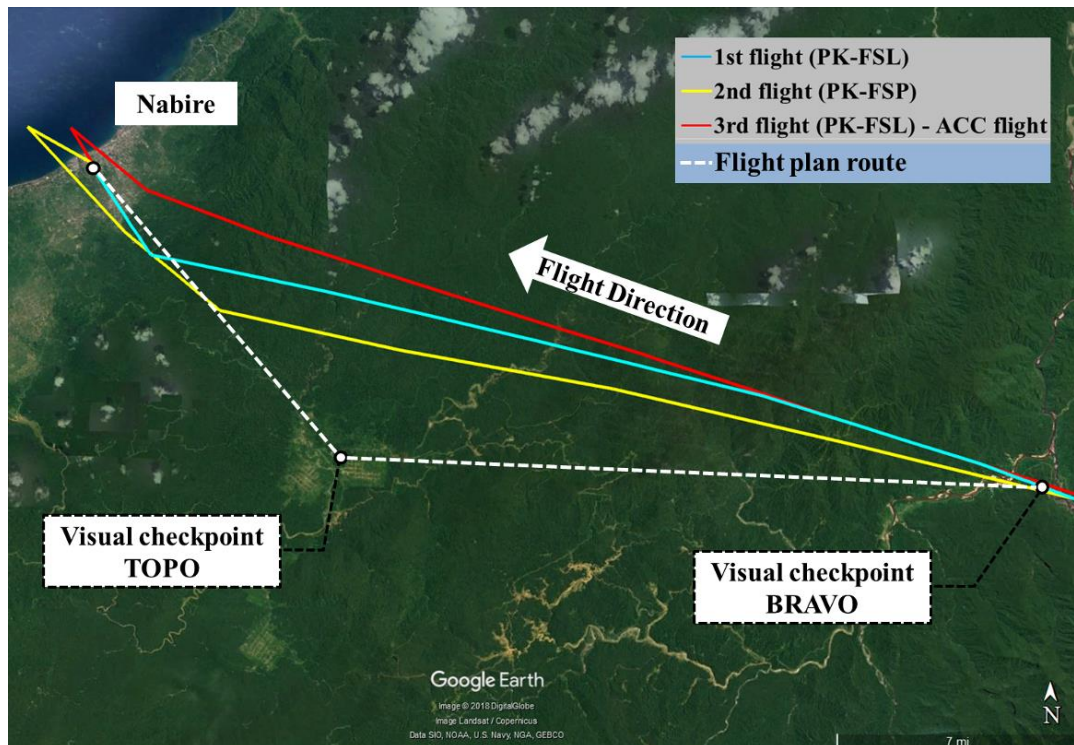
Figure 19: The flight profile of the Bilorai – Nabire flights on 18 June 2018

The investigation downloaded the reporting Spidertracks data of the three flights from Bilorai to Nabire during the day of the occurrence. The latitude and the longitude parameters were superimposed with Google Earth application as follow:
