**KOMITE NASIONAL KESELAMATAN TRANSPORTASI
REPUBLIC OF INDONESIA**

Aircraft Accident Investigation Report

PT. Spirit Avia Sentosa (FlyingSAS)

Cessna 208B, PK-FSL

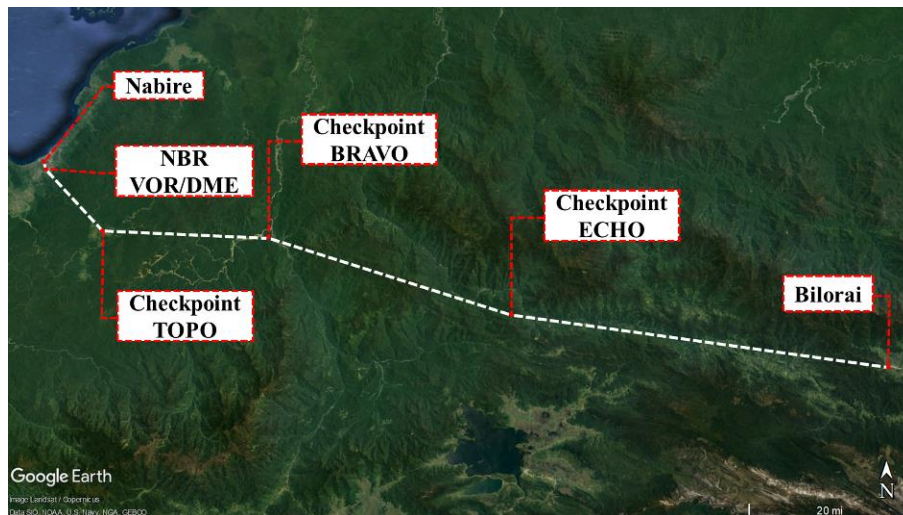
Figure 1: The flight plan route Bilorai to Nabire via checkpoint TOPO

The third flight from Nabire to Bilorai, the pilot used the PK-FSL aircraft again and landed safely in Bilorai. The pilot planned the flight return to Nabire as the first flight. The route was consistent with the filed flight plan signed by the PIC.

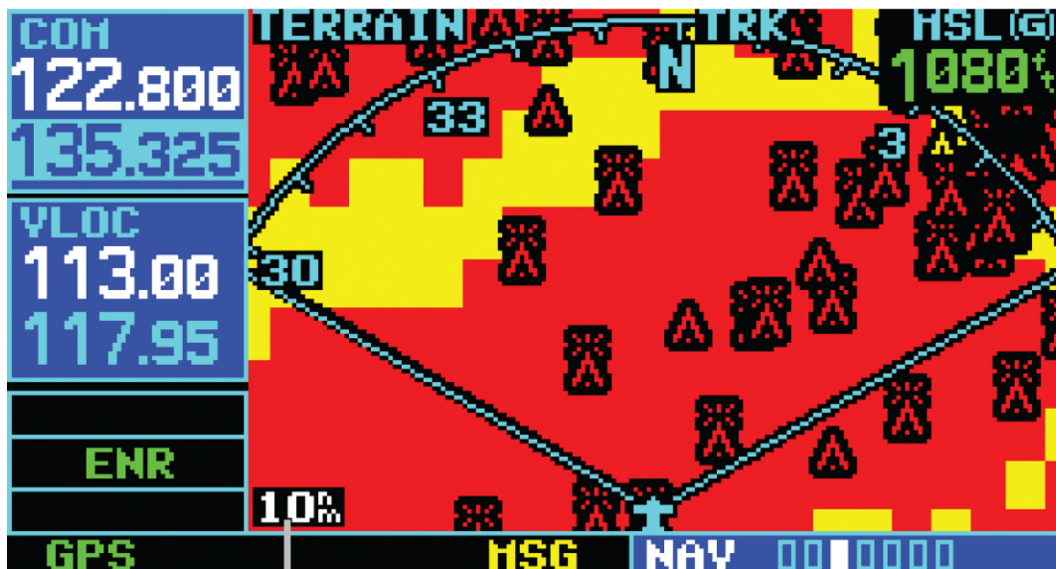
Figure 3: The TERRAIN page display

The GNS 430 have TERRAIN page which could display terrain information based on database of Terrain Data cards inserted on the GPS. The terrain information is visualized to pilot on the TERRAIN page of the display. The TERRAIN feature on this GPS is not intended to be used as a primary reference for terrain avoidance and does not relieve the pilot from the responsibility of being aware of surroundings during flight. The TERRAIN feature is only to be used as an aid for situational awareness of terrain avoidance and is not certified for use in applications requiring a certified terrain awareness system.

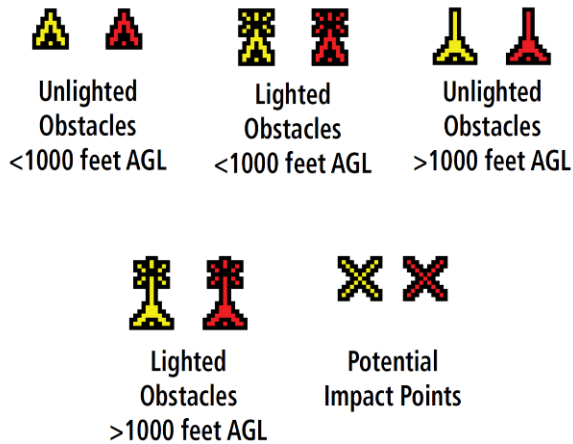
Figure 4: The TERRAIN symbols

The terrain information is visualized into color and symbols to represent obstacle and potential impact points. Red terrain color means the terrain/obstacle is above or within 100 feet below the aircraft altitude, yellow terrain color means the terrain/obstacle is between 100 and 1,000 feet below the aircraft altitude and black terrain color means the terrain/obstacle is more than 1000 feet below the aircraft altitude. The symbols used on the TERRAIN page are as follows:

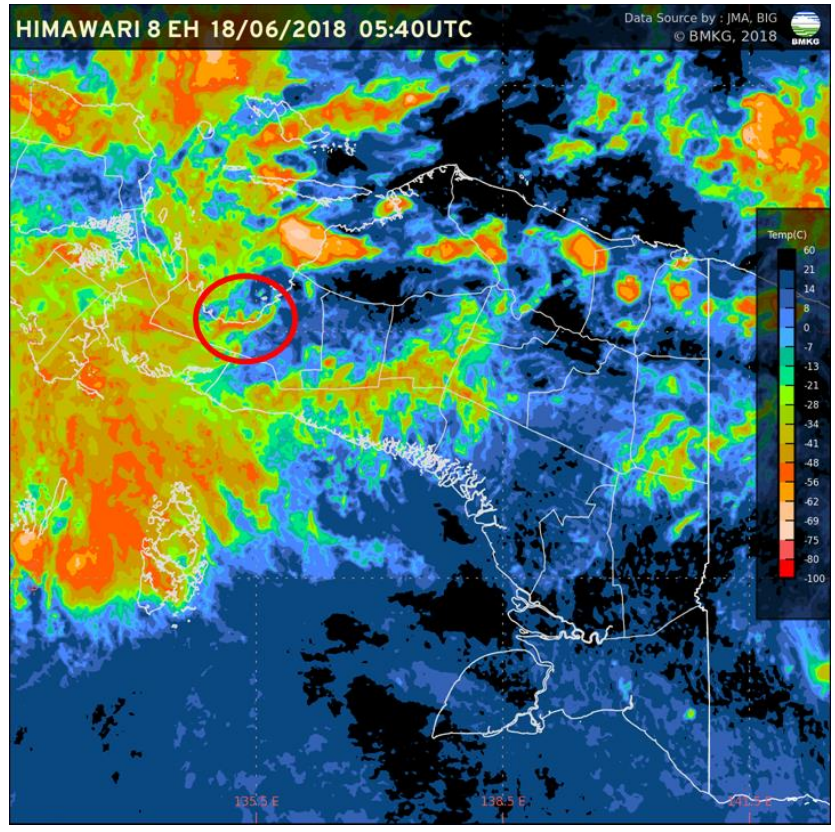
Figure 5: The satellite image of the occurrence site (red circle) at 0540 UTC

The following satellite images were provided by *Badan Meteorologi Klimatologi dan Geofisika* (BMKG – Bureau of Meteorology, Climatology and Geophysics) at 0540 UTC (1440 LT) and 0550 UTC (1450 LT). The images indicated significant development of clouds which potentially become Cumulonimbus.

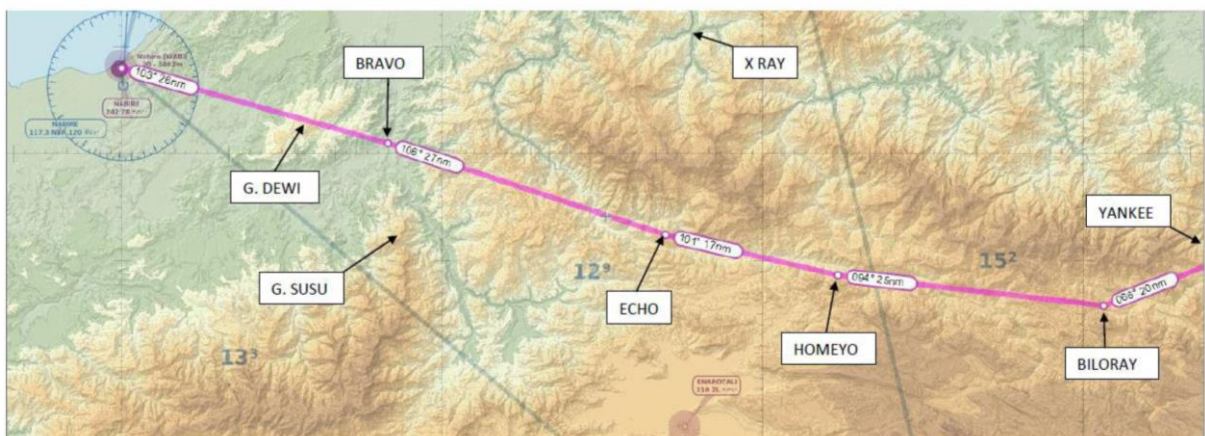
Figure 8: The VFR chart of Nabire – Sugapa

Aircraft inbound from West or North area is expected to contact Nabire Tower 60 Nm from Nabire. When clear of descend aircraft will be given clearance to 2500 feet and call at 10 Nm. If runway 16 in use then will be directed to intercept final runway 16. If runway 34 in use then will be directed to join left downwind runway 34. Aircraft inbound from East area must contact Nabire Tower when approaching Point B check point. After leaving Point B, aircraft shall tracking to Topo area then follow Nabire Tower instruction to call at 10 Nm. If runway 34 in use aircraft will be directed to join final runway 34. If runway 16 in use the aircraft will be directed to join right downwind runway 16. When using runway 34 aircraft will be making a high approach.

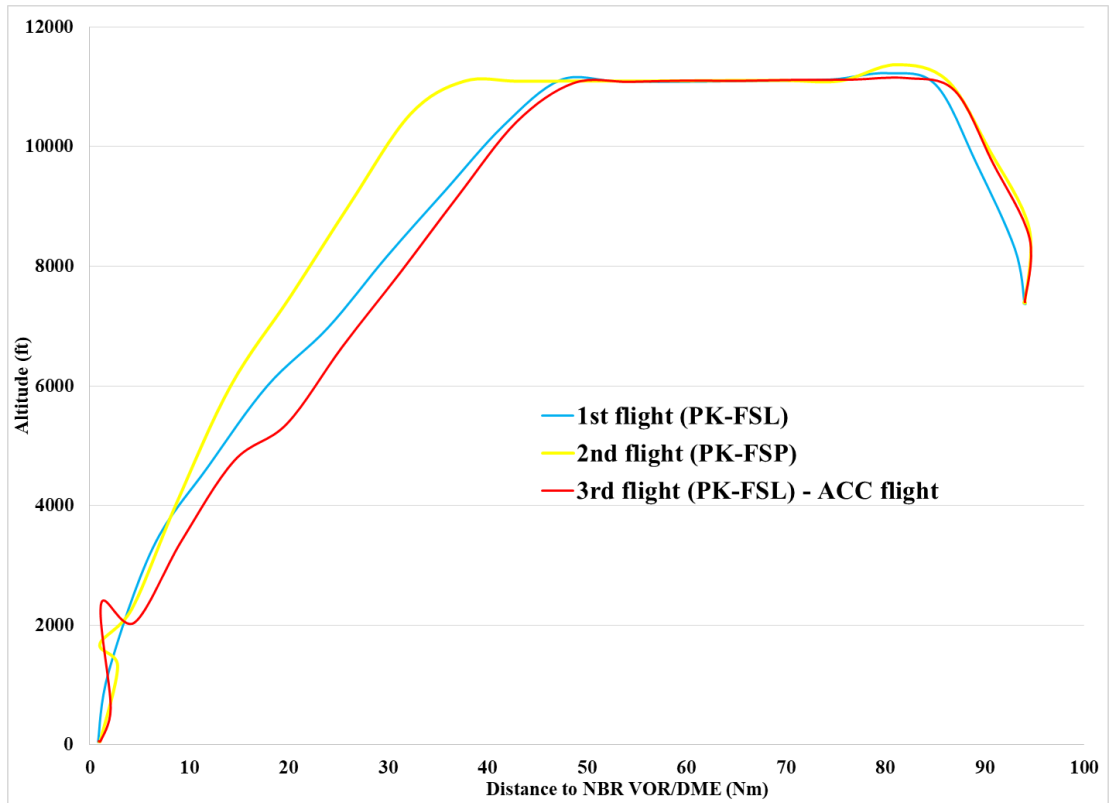
Figure 13: The altitude profile of the Bilorai – Nabire flights on 18 June 2018

The investigation downloaded the reporting Spidertracks data of the three flights from Bilorai to Nabire during the day of the occurrence.
