**KOMITE NASIONAL KESELAMATAN TRANSPORTASI
REPUBLIC OF INDONESIA**

KNKT.18.08.32.04

Aircraft Accident Investigation Report

PAC 750XL; PK-HVQ

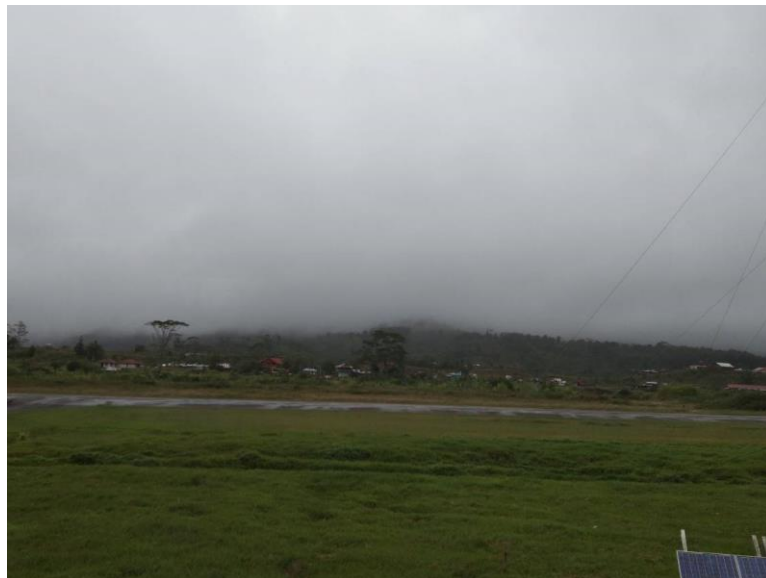
Figure 9: The right downwind runway 11 condition at 1507 LT

At 1411 LT, the meteorological condition reported by the Oksibil Tower controller was wind direction from 110° with velocity of 9 knots, the visibility 1 up to 2 km, on IWUR area, right down wind, right base of runway 11 were covered with clouds. Over the airport the cloud base was about 4,700 feet AGL (or about 500 feet above airport elevation). This information was based on the report of another pilot of arrival aircraft.

The following pictures were taken at 1507 LT by the Oksibil Tower controller showed the clouds condition which were similar to the condition at the time of the accident.

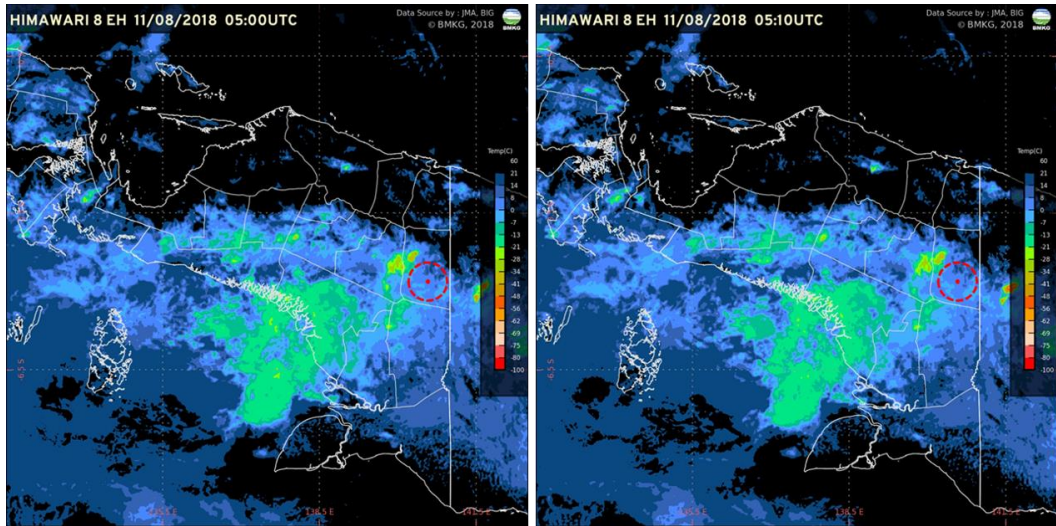
Figure 12: Enhanced infrared satellite image at 0500 UTC and 0510 UTC

The enhanced infrared satellite images at 0500 UTC (1400 LT) up to 0525 UTC (1425 LT) with interval 5 minutes indicated that the temperature on the accident site (red circle) was from 0 up to 8°C.

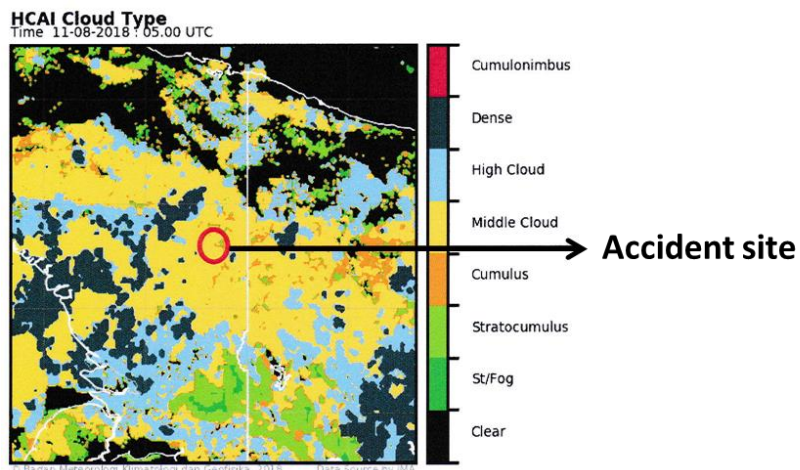
Figure 14: Cloud type satellite image at 0500 UTC (1400 LT)

The cloud type satellite images at 0500 UTC (1400 LT) and 0600 UTC (1500 LT) indicated middle cloud surrounded the accident site location.

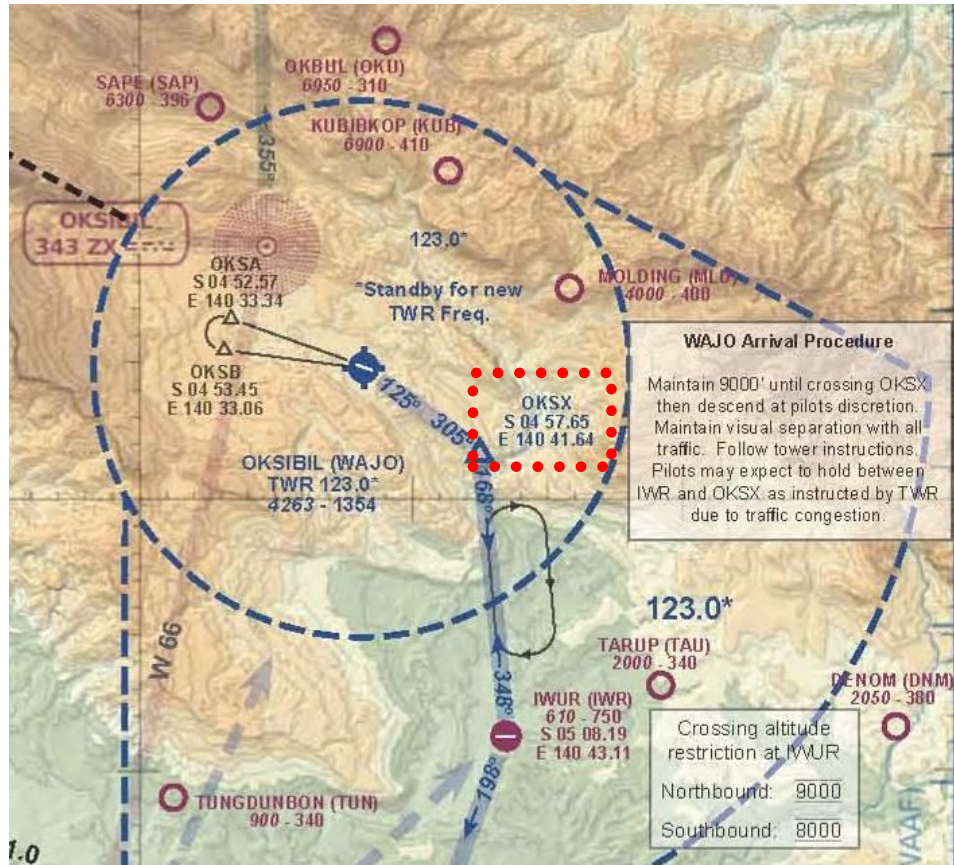
Figure 17: The OKSX location (red dot square) on visual guidance route published by other aircraft operator

The investigation was unable to find GPS checkpoint OKSX used by the pilot during the accident in the Dimonim Air OM – Part C or Route Manual.

The investigation found several aircraft operators issued route guidance for internal use that contained different check point location which used for internal use. The visual guidance route to Oksibil issued by another aircraft operator described GPS checkpoint OKSX located on coordinate 04° 57.65' S; 140° 41.64' E or about 4.9 Nm on bearing 125° from Oksibil.
