**KOMITE NASIONAL KESELAMATAN TRANSPORTASI
REPUBLIC OF INDONESIA**

Aircraft Accident Investigation Report

PT. Marta Buana Abadi (Dimonim Air)

PAC 750XL; PK-HVQ

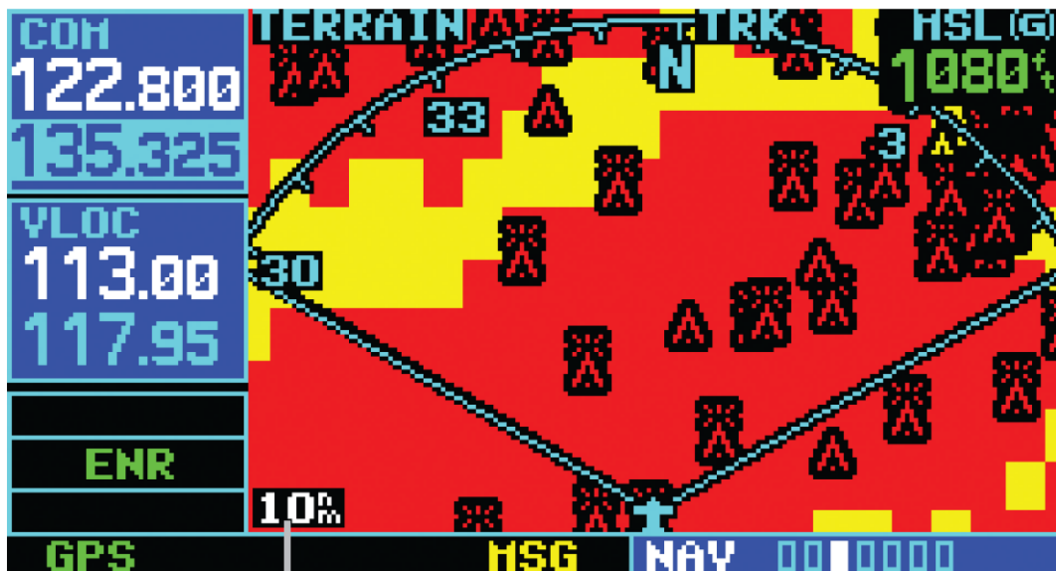
Figure 2: Sample of the TERRAIN page display

The GNS 430 has TERRAIN page which could display terrain information based on database of Terrain Data cards inserted on the GPS. The terrain information is visualized to pilot on the TERRAIN page of the display. The GNS 430 Pilot Guides and References stated that TERRAIN feature on this GPS is not intended to be used as a primary reference for terrain avoidance and does not relieve the pilot from the responsibility of being aware of surroundings during flight. The Garmin is a non-TSO-C151b-certified terrain awareness system incorporated into GNS 430 units to increase situational awareness and aid in reducing controlled flight into terrain (CFIT).

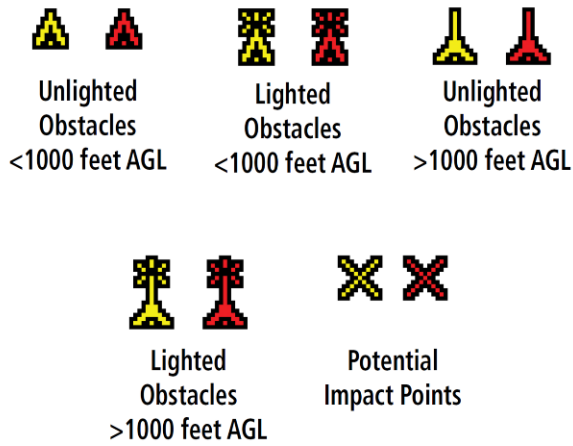
Figure 3: The TERRAIN page symbols

The terrain information is visualized into color and symbols to represent obstacle and potential impact points. Red terrain color means the terrain/obstacle is above or within 100 feet below the aircraft altitude, yellow terrain color means the terrain/obstacle is between 100 and 1,000 feet below the aircraft altitude and black terrain color means the terrain/obstacle is more than 1000 feet below the aircraft altitude. The symbols used on the TERRAIN page are as follows:

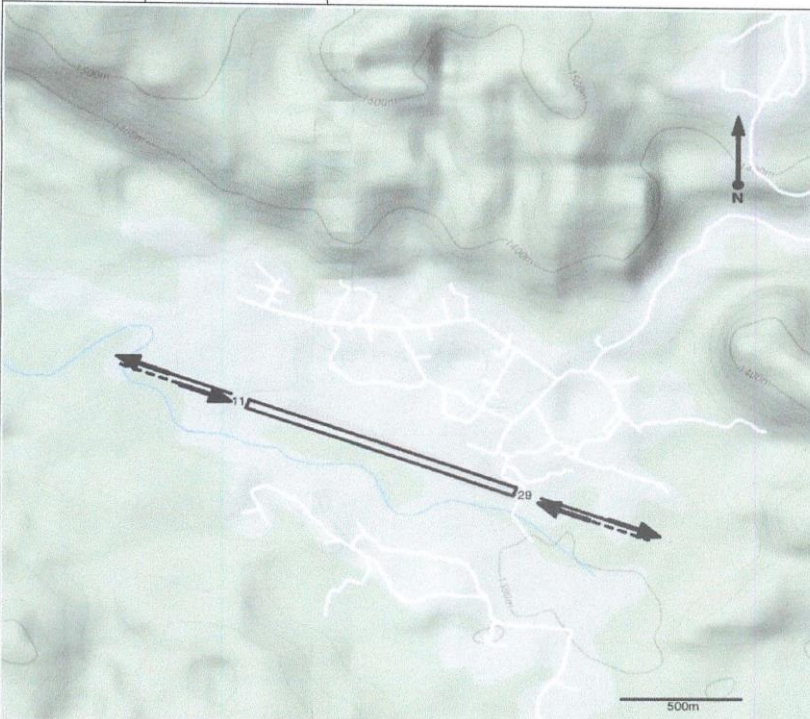
Landing: 11 / 29 Take-Off: —
			Elev (TDZ): 4000' Elev (TOP):
			Length: 1200m Width: 20m
			Slope: 0%
			Surface: Sealed
			MLDW: Full MTOW: Full
			Max GS: —
