**KOMITE NASIONAL KESELAMATAN TRANSPORTASI
REPUBLIC OF INDONESIA**

Aircraft Accident Investigation Report

Boeing 737-800; PK-LOO

Djalaluddin Airport, Gorontalo

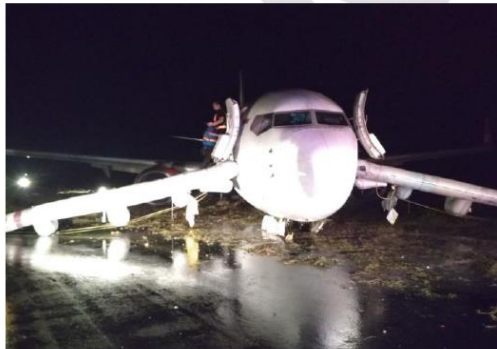
On 29th April 2018 Lion Air B737-800 with registration PK-L00 performing flight route from Makassar (UPG) to Gorontalo (GTO) was land in rain condition, veer-off/excursion to the left side of runway approximately stop at mid distance. Half of the aircraft on the runway pavement, while the other half beyond runway edge. Nose landing gear damage found. Evacuation process went well without any injuries for both passengers and crews.

1. To respect of Stabilization Approach criteria
2. To respect of Mandatory Missed Approach criteria
3. To increase awareness when weather deterioration occurs such as time by time visibility reduction
4. To ensure, implement anything related to requirement, prohibition or limitation stated in OM-C
5. To review crew coordination and standard call out during approach
6. To increase crew assertiveness, particularly as pilot monitoring
