**KOMITE NASIONAL KESELAMATAN TRANSPORTASI
REPUBLIC OF INDONESIA**

Aircraft Accident Investigation Report

Super Decathlon 8KCAB; PK-RTZ

Tunggul Wulung Airport, Cilacap Central Java

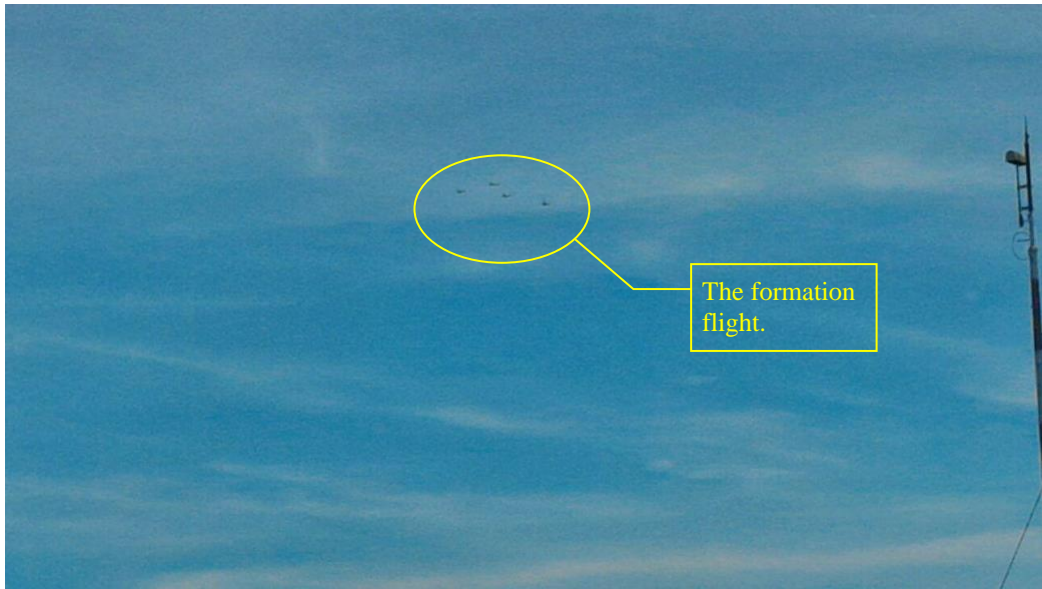
Figure 7: The formation flight and the weather at the time of occurrence

Based on observation to the video footage of the formation and aerobatic flight found that the weather during the flight met the requirement for Visual Meteorological Condition (VMC).
