**KOMITE NASIONAL KESELAMATAN TRANSPORTASI
REPUBLIC OF INDONESIA**

KNKT.19.05.10.04

Aircraft Accident Investigation Report

Airbus A320; PK-LZJ

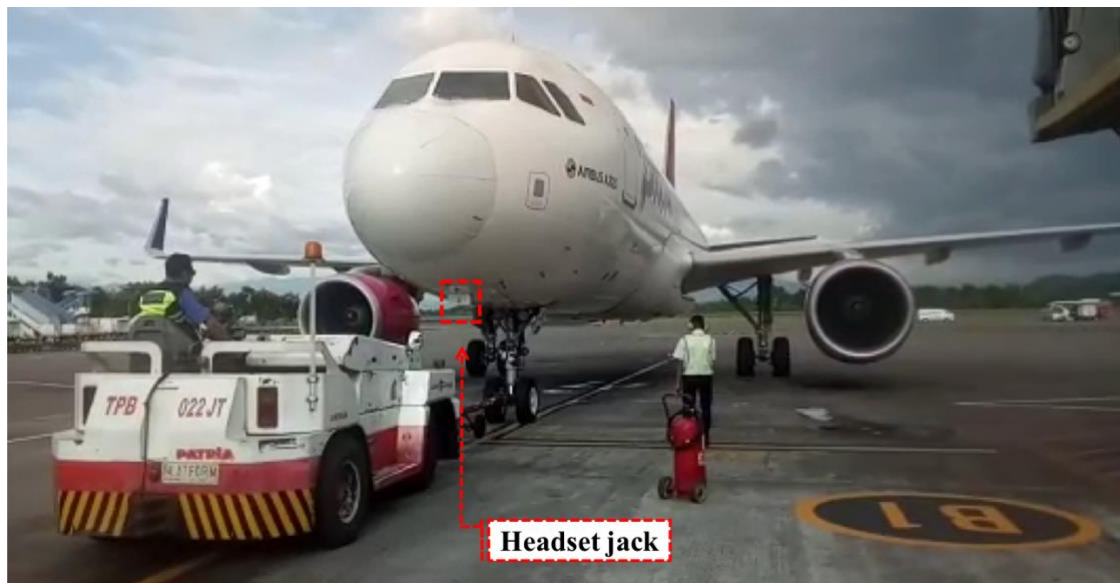
Figure 1: The common push back activity and the location of headset jack on typical Airbus A320

The headset jack (connector) for headset-man to plug his headset was located in the nose area of the aircraft (see figure 1).

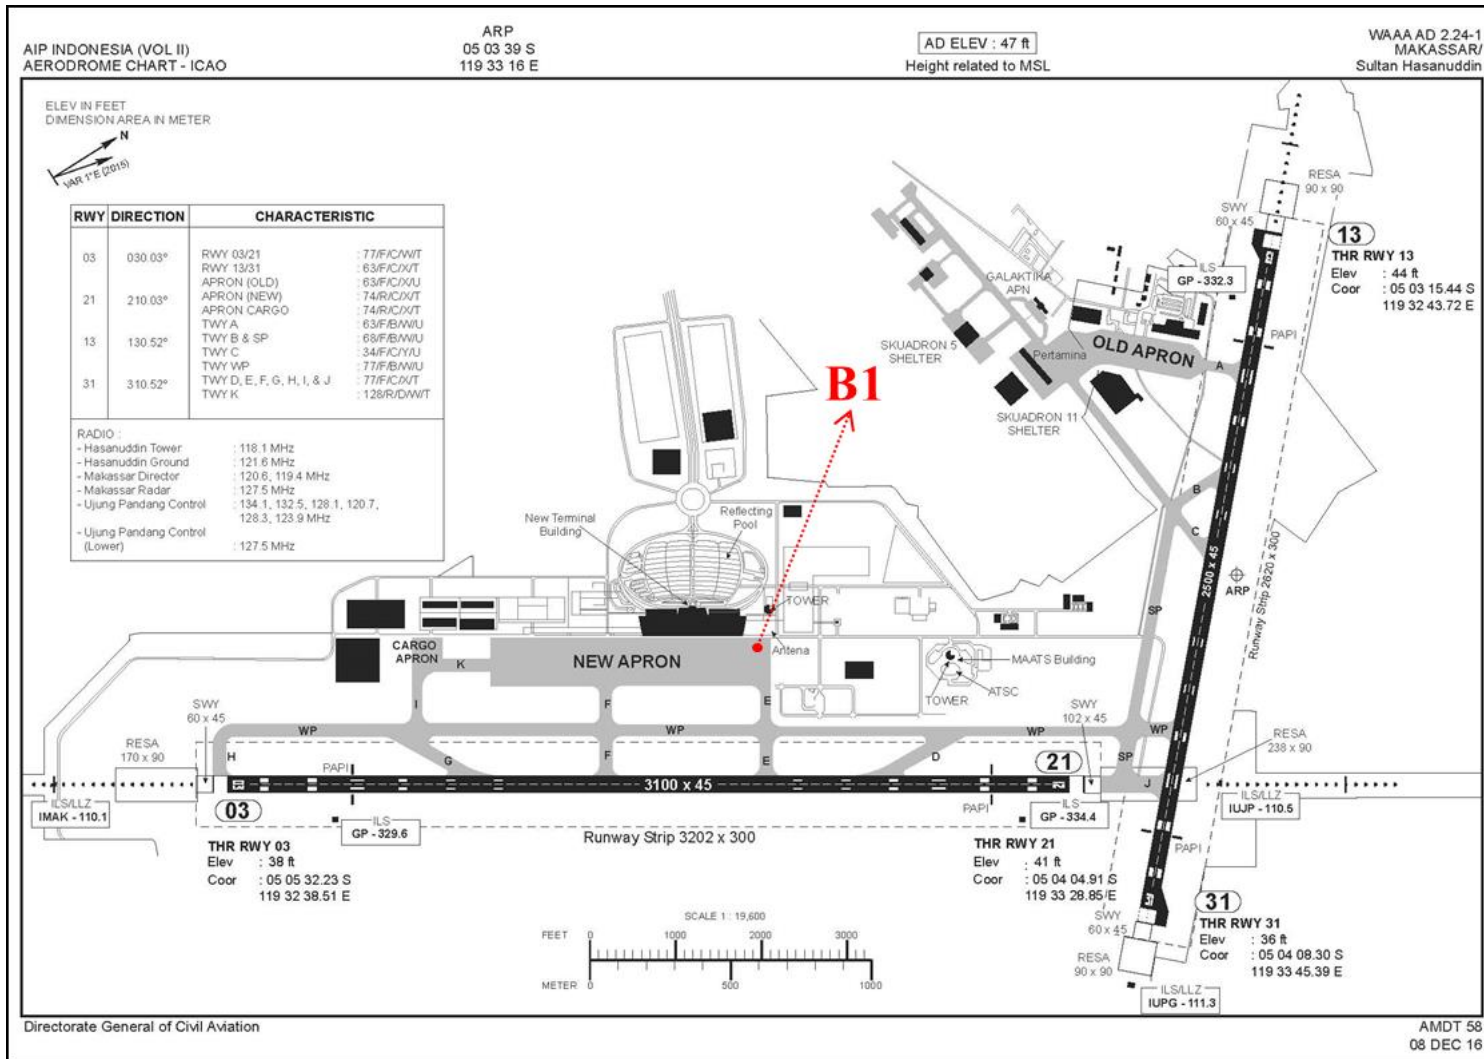
Figure 2: The apron layout

The airport had two runways (03-21 and 13-31), 13 taxiways, three aprons (new, old and cargo), and 37 parking stands. The airport layout can be seen on figure 2.

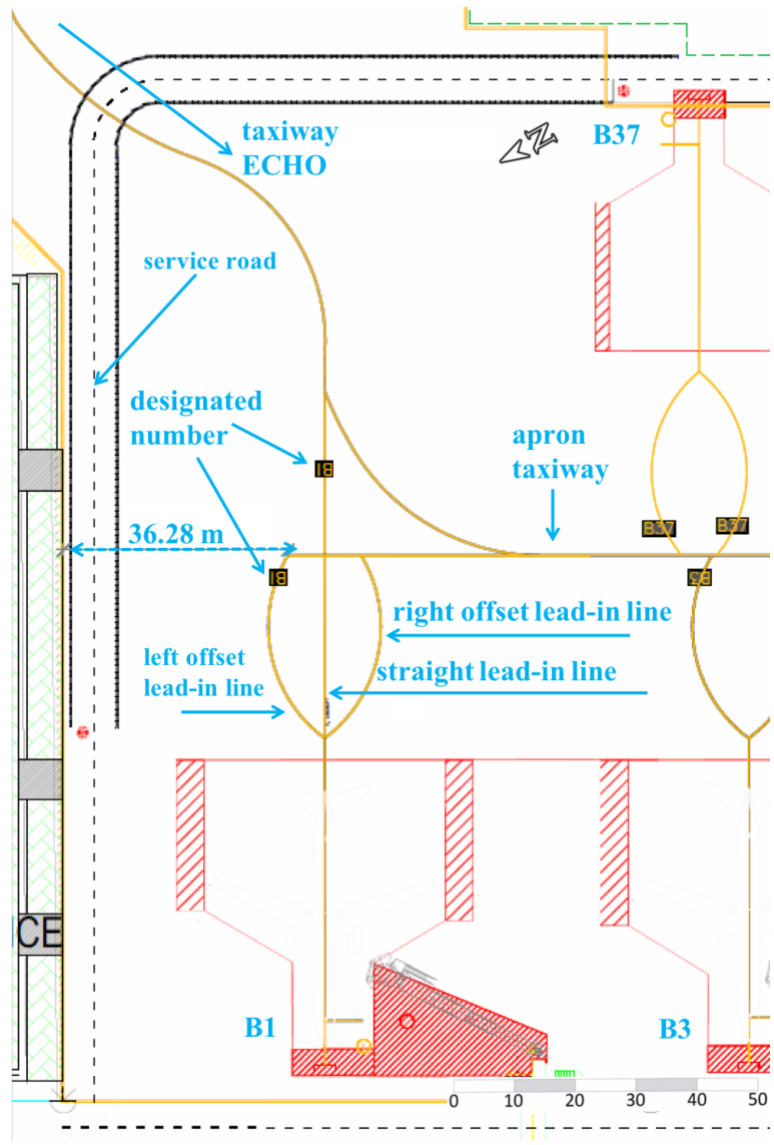
Figure 3: Parking stand B1 layout

The right offset lead-in line could not be used for taxi in guidance, as there was no taxi route from north east direction. The left offset lead-in line is used for aircraft which taxi from taxiway FOXTROT (south-west direction). The straight lead-in line is used for aircraft which taxied from taxiway ECHO (south-east direction). Therefore, the designated number of parking stand B1 only painted on the left offset nose-wheel lead-in line and straight lead-in line.

The left offset lead-in line can be used as pushback guidance for aircraft facing north east, while the right offset lead-in line and straight lead-in line were provided as pushback guidance for aircraft to face south-west direction. If the right offset lead-in line would be used for pushback guidance, the aircraft maneuver will be too close to the service road, and if the straight lead-in line would be used, the aircraft have to be pushed straight back close to taxiway ECHO until the nose wheel can taxi following the apron taxiway centerline marking.

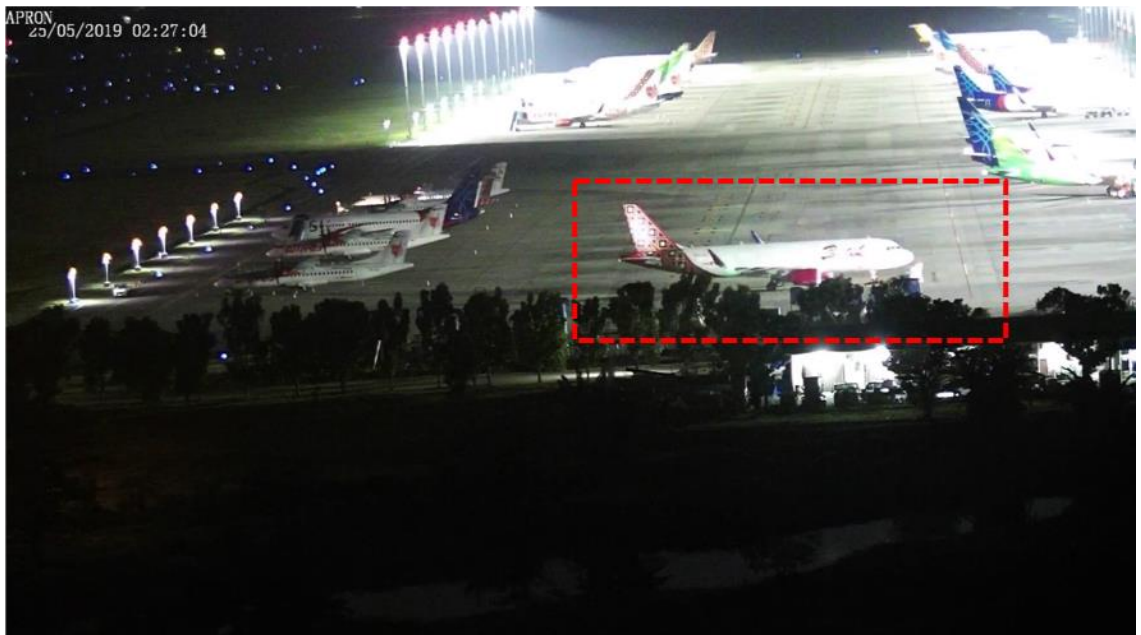
Figure 5: The aircraft as recorded by the ATS provider CCTV system

The Air Traffic Services (ATS) provider also utilized CCTV system for security purposes. One of the CCTV cameras located outside the tower building facing to the apron recorded the push back maneuver. Based on the CCTV record, throughout the pushback maneuver, the headset-man position as such that the nose wheels were behind him (figure 6).

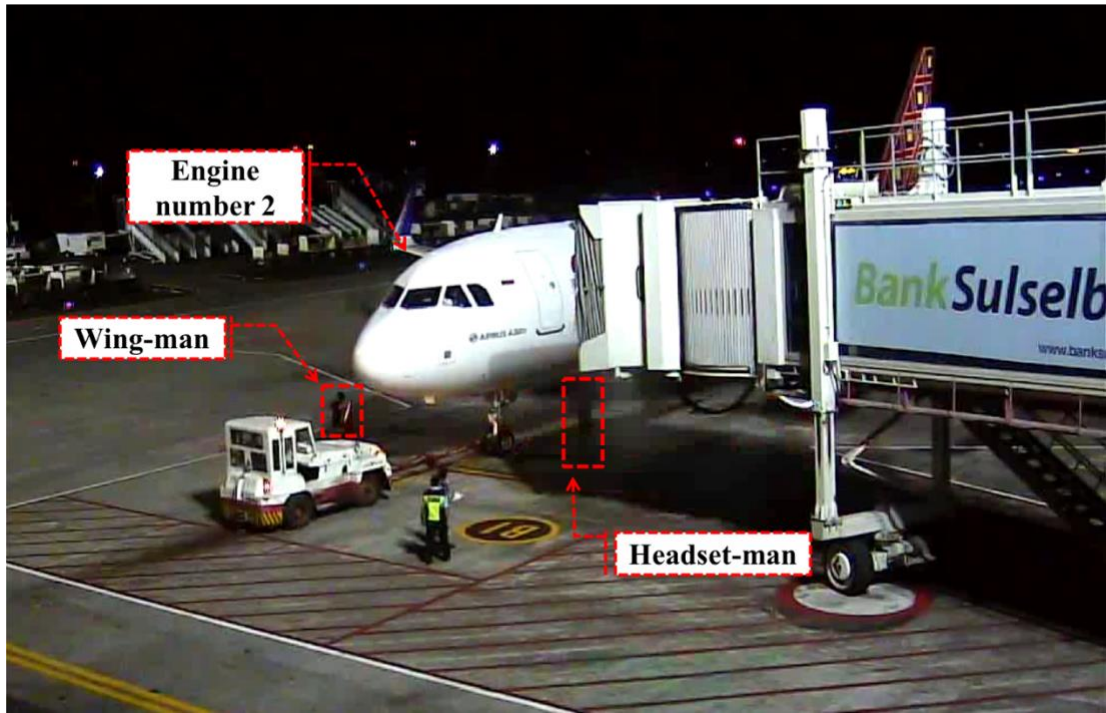
Figure 8: The view from CCTV, 4 seconds after the aircraft moved

The location of the blood spills on coordinate 5°4'32.86"S; 119°32'55.67"E, about 50 meters from the beginning of parking stand B1, was considered as the location when the nose wheel passed over the headset-man right foot.

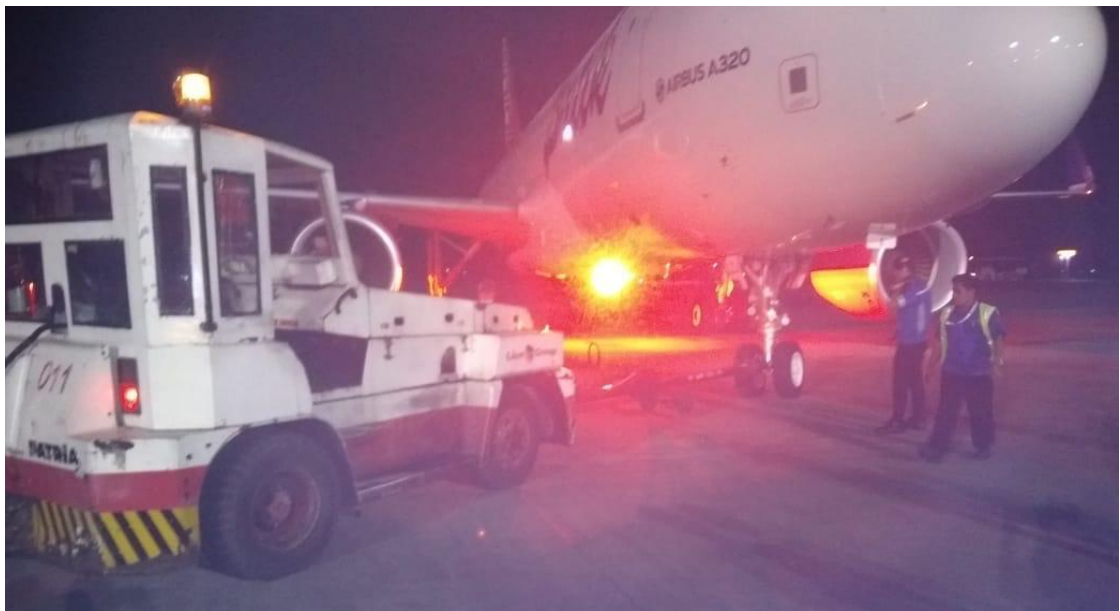
Figure 9: The position of the towing tractor and when the aircraft stopped after the accident

After the bump, the towing tractor driver stopped the towing tractor and the aircraft stopped by facing south east. The aircraft was undamaged.

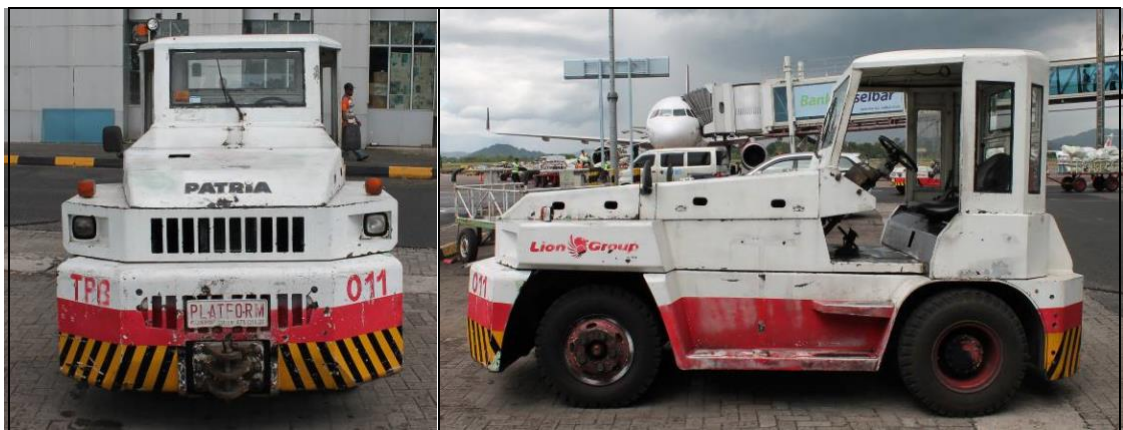
Figure 12: The towing tractor

The towing tractor manufactured by PT. United Tractors Pandu Engineering (PATRiA), Indonesia and the model PTD 50 is capable to tow Airbus A320. According to the product specification, the maximum speed for PTD 50 with forward-1 clutch is 12 km/hour and forward-2 clutch is 32 km/hour. The steering wheel of the PTD 50 is left hand drive which the steering wheel is on the left side.

Prior to the accident, there was no report or record of towing tractor system malfunction.

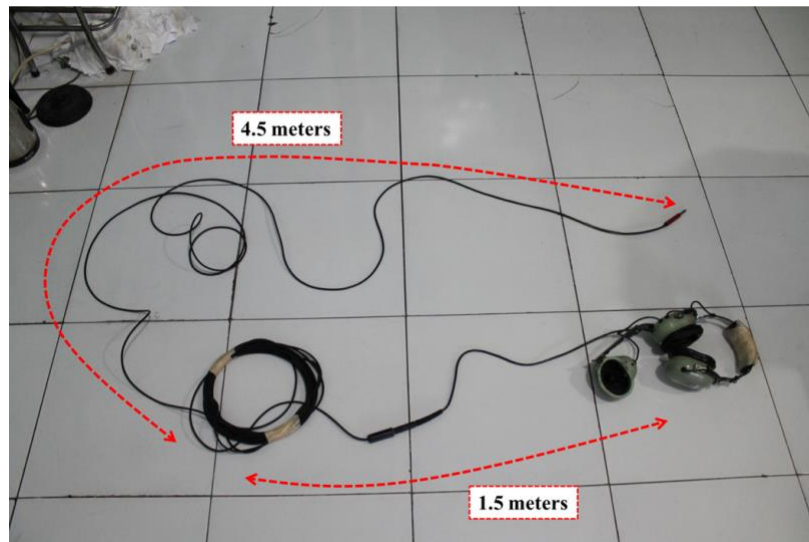
Figure 13: The headset used by the headset-man during the accident

The headset-man utilized wired headset manufactured by David Clark Company with product code of ML0715-28. During the accident the headset cable was rolled up and headset-man held the rolled-up cable. The total length the headset on rolled-up condition was 6 meters, from the headset to rolled-up cable was about 1.5 meters while from rolled-up to headset jack was about 4.5 meters. Prior to and during the accident, there was no record or report of headset malfunction.
