**Aircraft Serious Incident Investigation Report**

**PT Sinar Mas Super Air**

**Pacific Aerospace FU 24-950 Fletcher; PK-PNZ**

**Mambruk Airstrip, Lereh, Papua**

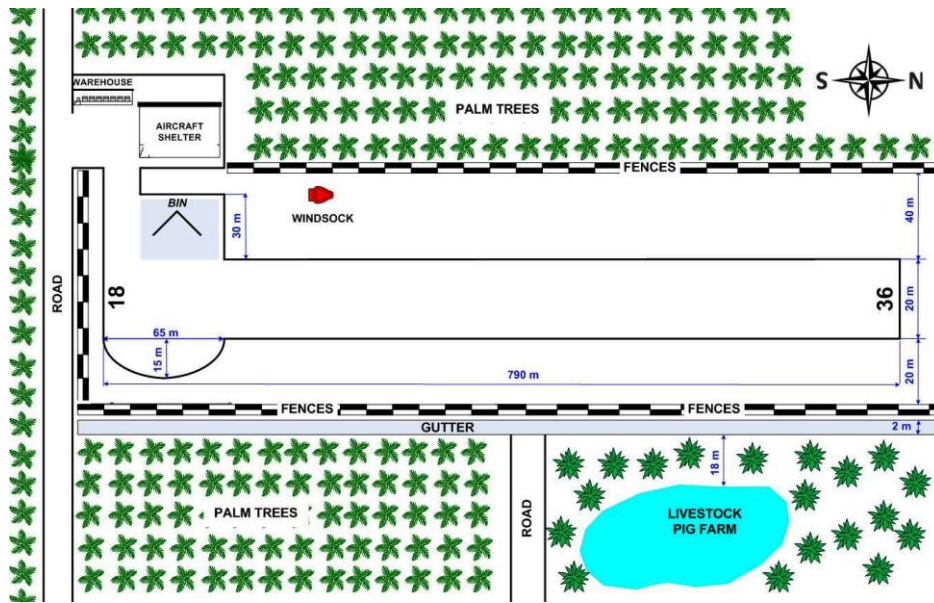
Figure 4: Mambruk Airstrip

The east side area of Mambruk airstrip was palm plantation area while the west side was area dedicated as conservation. No activity allowed within the conservation area as it may disturbed the environment and the wild life. However, some local people utilized the conservation area on the left side of threshold runway 36 as livestock boar farming.
