**KOMITE NASIONAL KESELAMATAN TRANSPORTASI
REPUBLIC OF INDONESIA**

Aircraft Accident Investigation Report

Airbus MBB BK117 D-2 Helicopter; PK-JBX

Bersujud Airport, Batulicin

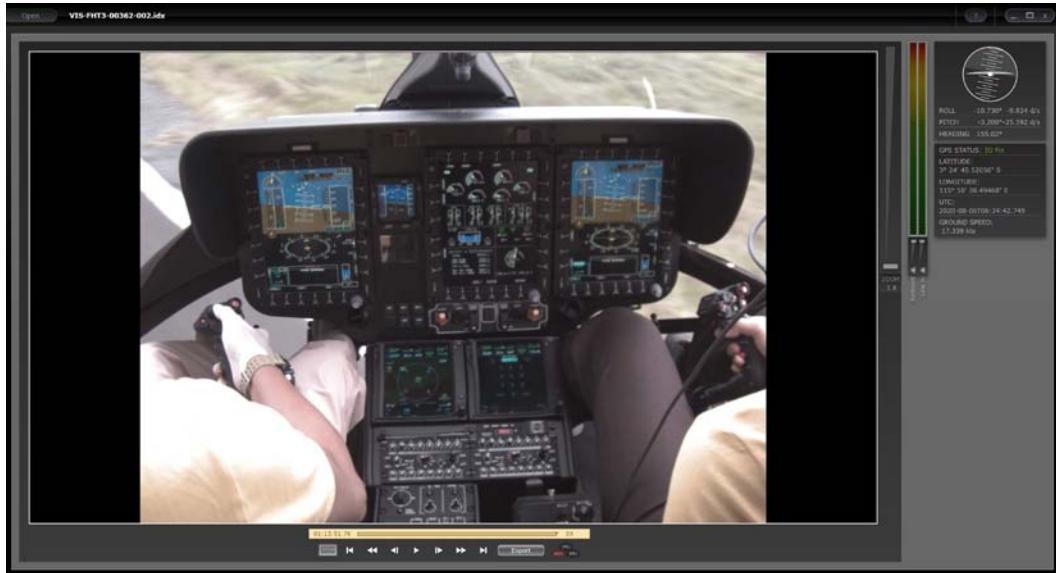
Figure 4: *Appareo* Vision 1000 FDRI screenshot

KNKT successful download the 16 GB memory card and contain data approximately 4 hours of aircraft operation, including 1 hour 14 minutes of the accident flight. The 16 GB memory card contain video (movie) file and WAAS GPS data, no voice data was recorded.

The KNKT laboratory succeeded combine Vision 1000 FDRI data with voice data from Cockpit Voice & Data Recorder.
