**KOMITE NASIONAL KESELAMATAN TRANSPORTASI
REPUBLIC OF INDONESIA**

KNKT.20.06.10.04

Aircraft Serious Incident Investigation Report

AT-802A; PK-PAG

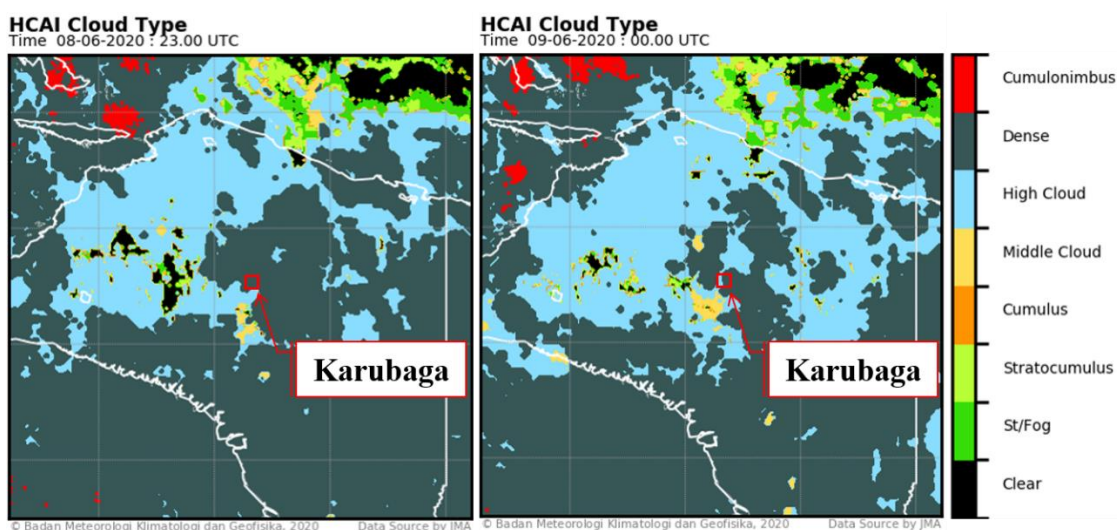
Based on the satellite images provided by *Badan Meteorologi Klimatologi dan Geofisika* (BMKG – Bureau of Meteorology, Climatology and Geophysics), on 2300 UTC (0800 LT) and 0000 UTC (0900 LT), indicated several convective clouds (dense)⁶ over Karubaga.

Figure 2: The satellite image of the Karubaga (red square)

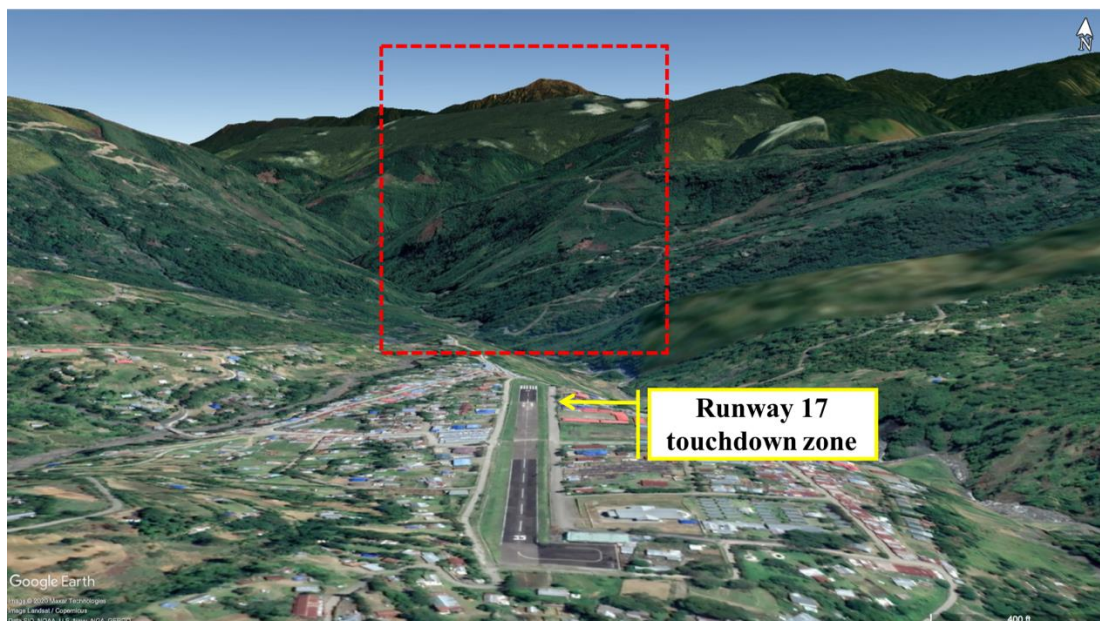
Figure 3: The terrain area on final runway 17 (red-dotted square)
