Aircraft Accident Investigation Report

PAC 750 XL; PK-RWR

Bayabiru Airstrip, Paniai, Papua

15 October 2020

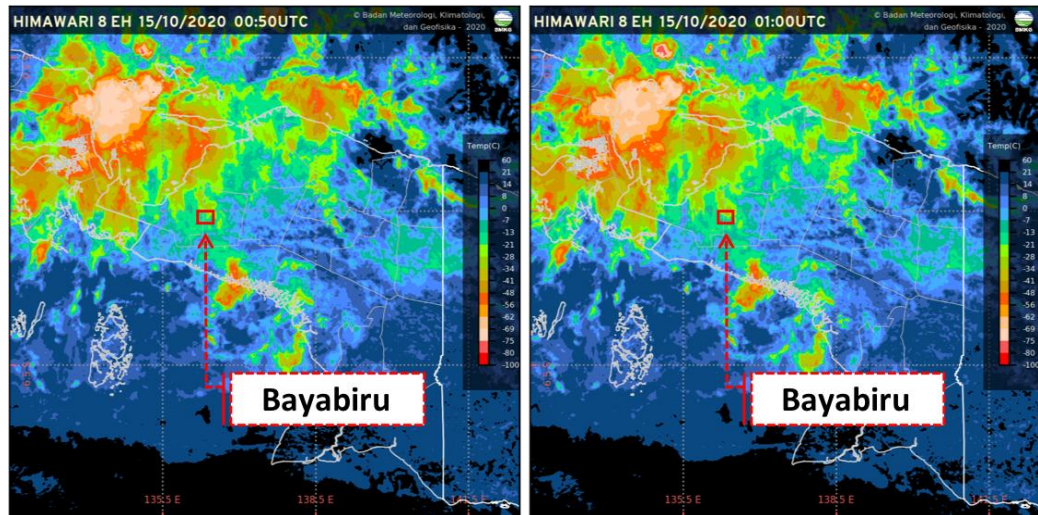
Based on the satellite images provided by *Badan Meteorologi Klimatologi dan Geofisika* (BMKG – Bureau of Meteorology, Climatology and Geophysics), on 0050 UTC (0950 LT) and 0100 UTC (1000 LT), indicated several convective clouds (dense)⁹ over Bayabiru with temperature between -7 up to -41°C.

Figure 1: The satellite image of the Bayabiru (red square)

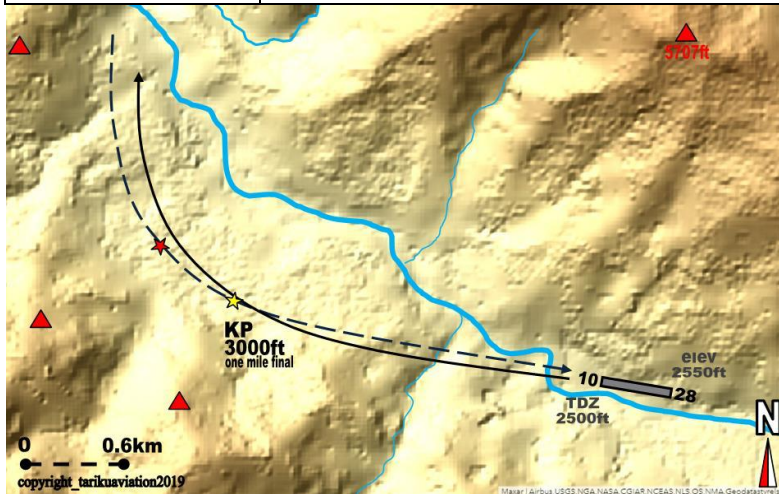
Length: 350 m
Width: 30 m
Slope: 5% TDZ, 7%, level at top.
Surface: Grass, Slippery when wet
Weight Limits(T/O): 300 Kg
Finals: 75 KIAS
Runway:
T/O: 28
LDG: 10

Location/Terrain: Situated in a tight valley, terrain to the north and south.
Weather Pattern: Occasional early morning fog and rain by midday. Wind picks up around noon (1200).
Aborted Approach: Turning final go around straight ahead. Swerve right if unable to stop.
Aborted Takeoff: At brake release, swerve right if unable to stop.
EFATO Locations: Along the river.
Hazards / Notes: Lot of helicopter traffic. People, animals crossing the runway no fence, incursion possible. Can be slippery and soft if wet. Side slope parking area.
