**KOMITE NASIONAL KESELAMATAN TRANSPORTASI
REPUBLIC OF INDONESIA**

KNKT.20.01.02.04

Aircraft Serious Incident Investigation Report

PK-SNP, Cessna 208B (EX)

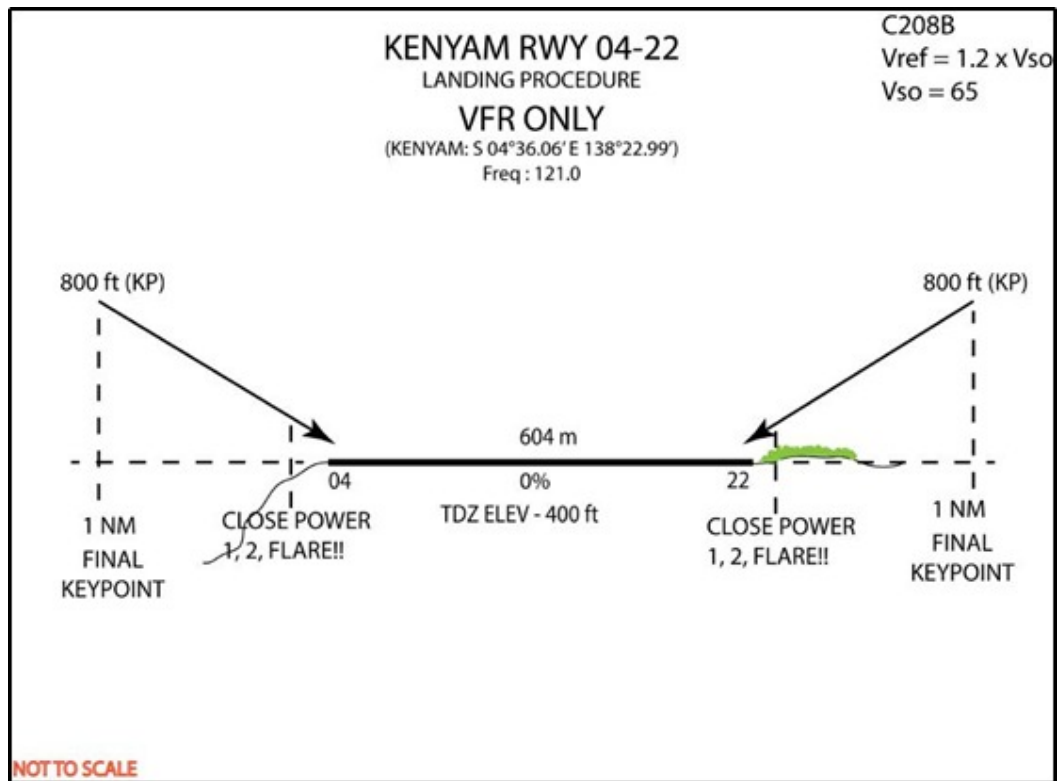
Figure 3: Kenyam landing procedure based on OM-Part B

1. *Begin descent as per appropriate TOD from 7,500 ft*
2. *Over view the field:*
 - *Make a wide east downwind if landing runway 22*
 - *Speed – 100 kts or below*
 - *Propeller – MAX (FULL FORWARD)*
 - *FLAPS – 20° (TO/APP)*
 - *All checks completed*
3. *Abeam TDZ*
 - *FLAPS – FULL*
 - *Vref – as appropriate depending on the LDW, consider the short and gravel (unimproved) strip*
 - *KP at 1 nm final at 800 ft*
