**KOMITE NASIONAL KESELAMATAN TRANSPORTASI  
REPUBLIC OF INDONESIA**

# **PRELIMINARY**

**Aircraft Accident Investigation Report**

**PT. Trigana Air Service  
Boeing B737-300; PK-YSG  
Sentani International Airport, Jayapura  
Republic of Indonesia  
25 February 2020**

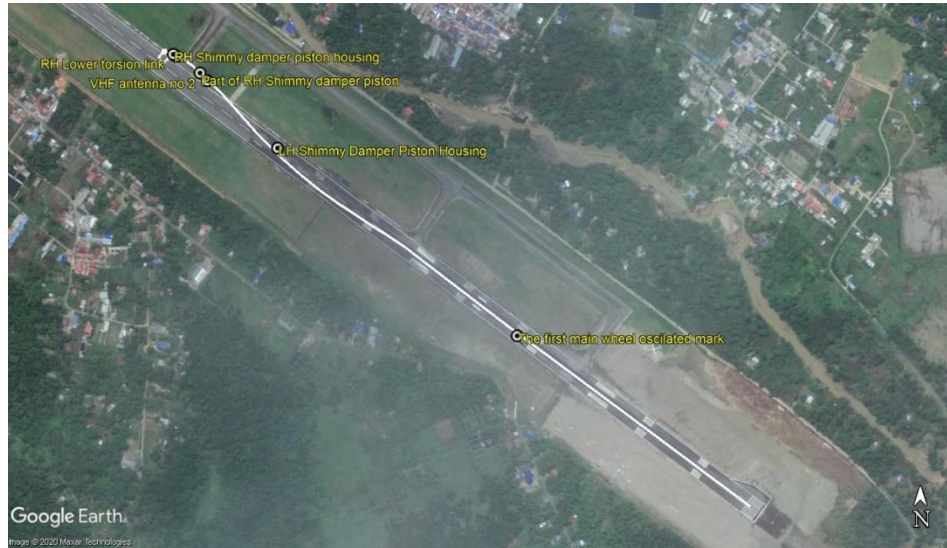
**Figure 17: Takeoff roll track**

The aircraft took off from the runway 30 and stop about 1,600 meters from the beginning of the runway 30. Based on the wheels mark on the runway, the investigation traced the track using the handheld GPS to visualize took off track.

The first oscillation wheels marks were found to since about 500 meters from the beginning runway 30 until the position of the aircraft stop. Part of the oscillation wheel marks is shown in the figure below.
