**KOMITE NASIONAL KESELAMATAN TRANSPORTASI
REPUBLIC OF INDONESIA**

1st INTERIM STATEMENT

Aircraft Serious Incident Investigation Report

Airbus A320; PK-LUT

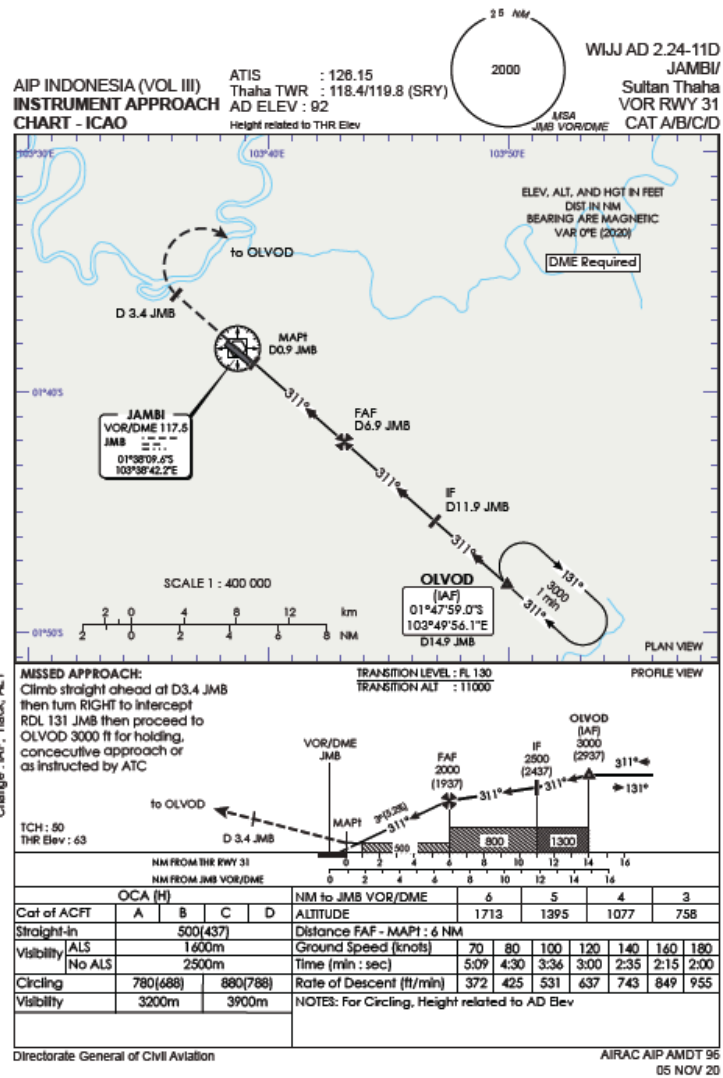
Figure 2: VOR Approach chart runway 31

The following is the Instrument Approach Chart for Very High Frequency Omni-Range (VOR) approach runway 31 of Jambi.

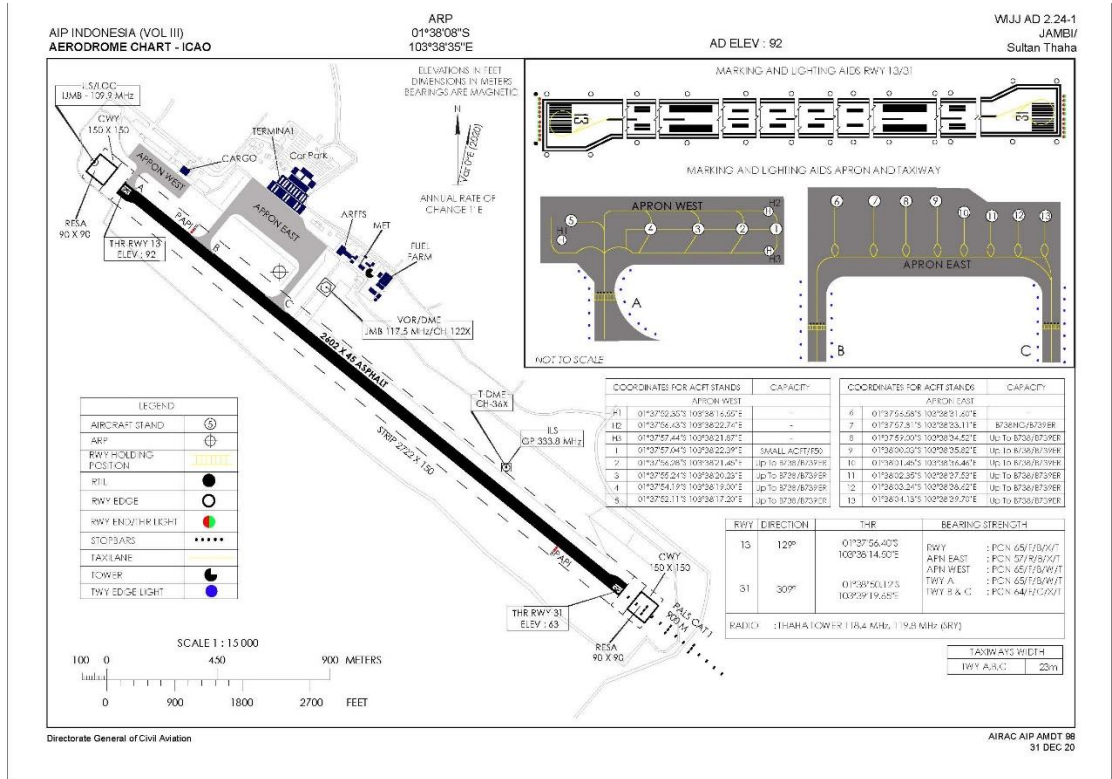
Figure 3: Jambi Airport layout

Airport Name : Sultan Thaha Airport
 Airport Identification : WIIJ/DJB
 Airport Operator : PT Angkasa Pura II (Persero)
 Airport Certificate : 010/SBU-DBU/XII/2020
 Validity : Valid until 7 July 2025
 Coordinate : 01° 38' 08" S; 103° 38' 35" E

Elevation : 92 feet
 Runway Direction : 13 – 31
 Runway Length : 2,602 meters
 Runway Width : 45
 Surface : Asphalt
