**KOMITE NASIONAL KESELAMATAN TRANSPORTASI
REPUBLIC OF INDONESIA**

1st INTERIM STATEMENT

Aircraft Accident Investigation Report

Robinson R44 Raven II; PK-RTO

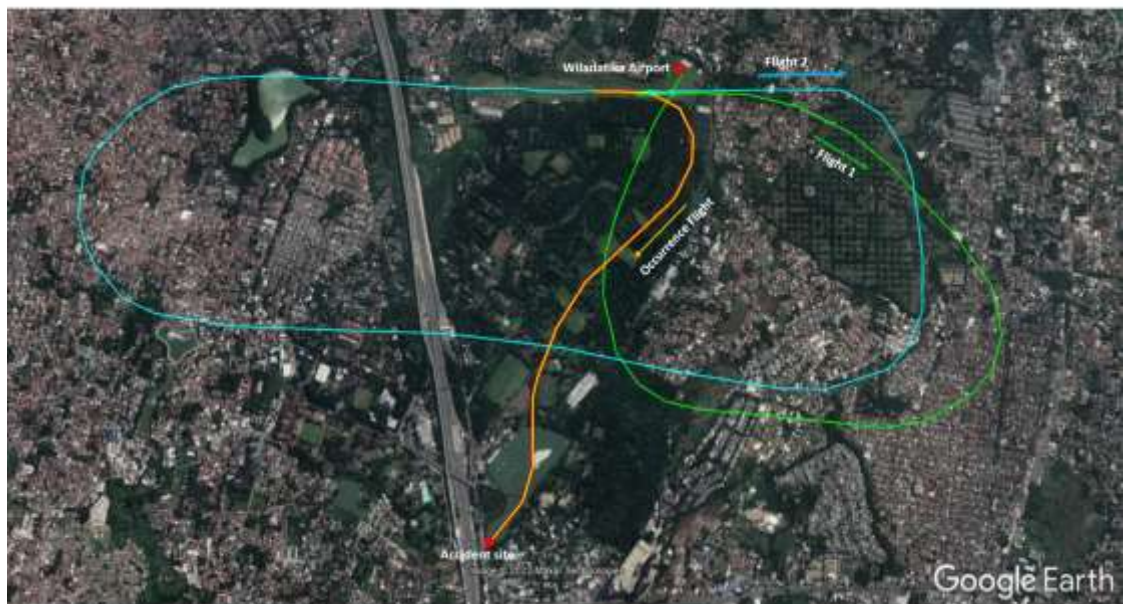
The data for the accident flight recorded 14 parameters on approximately 26 minutes of flight operation. The investigation utilized the flight data log to retrieve the flight path and imposed to Google Earth (figure 4).

Figure 4. The flight data log superimposed to Google Earth, the orange line shows the trajectory of the occurrence flight.
