**KOMITE NASIONAL KESELAMATAN TRANSPORTASI
REPUBLIC OF INDONESIA**

Aircraft Accident Investigation Report

PT Smart Cakrawala Aviation

Cessna Caravan C208B EX; PK-SNW

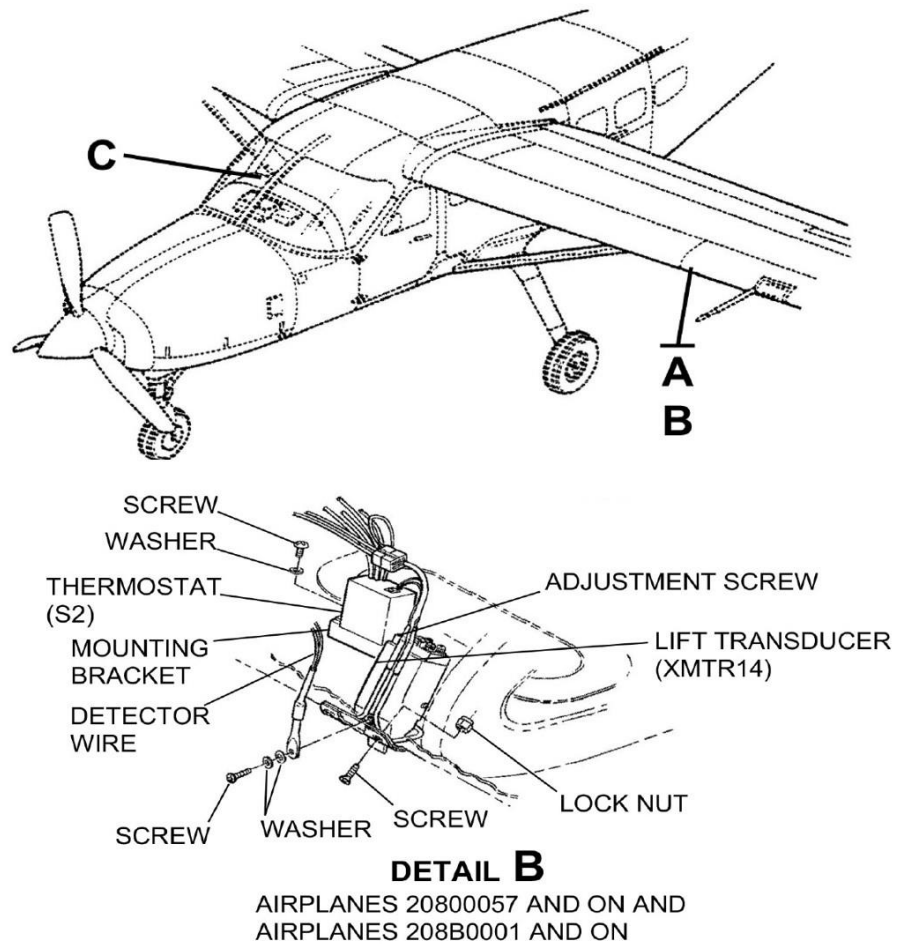
Figure 3: The Stall Warning component and installation

The vane senses the changes in airflow over the wing and activates the warning horn at airspeeds between 5 and 10 knots above the stall speed, in all configurations.

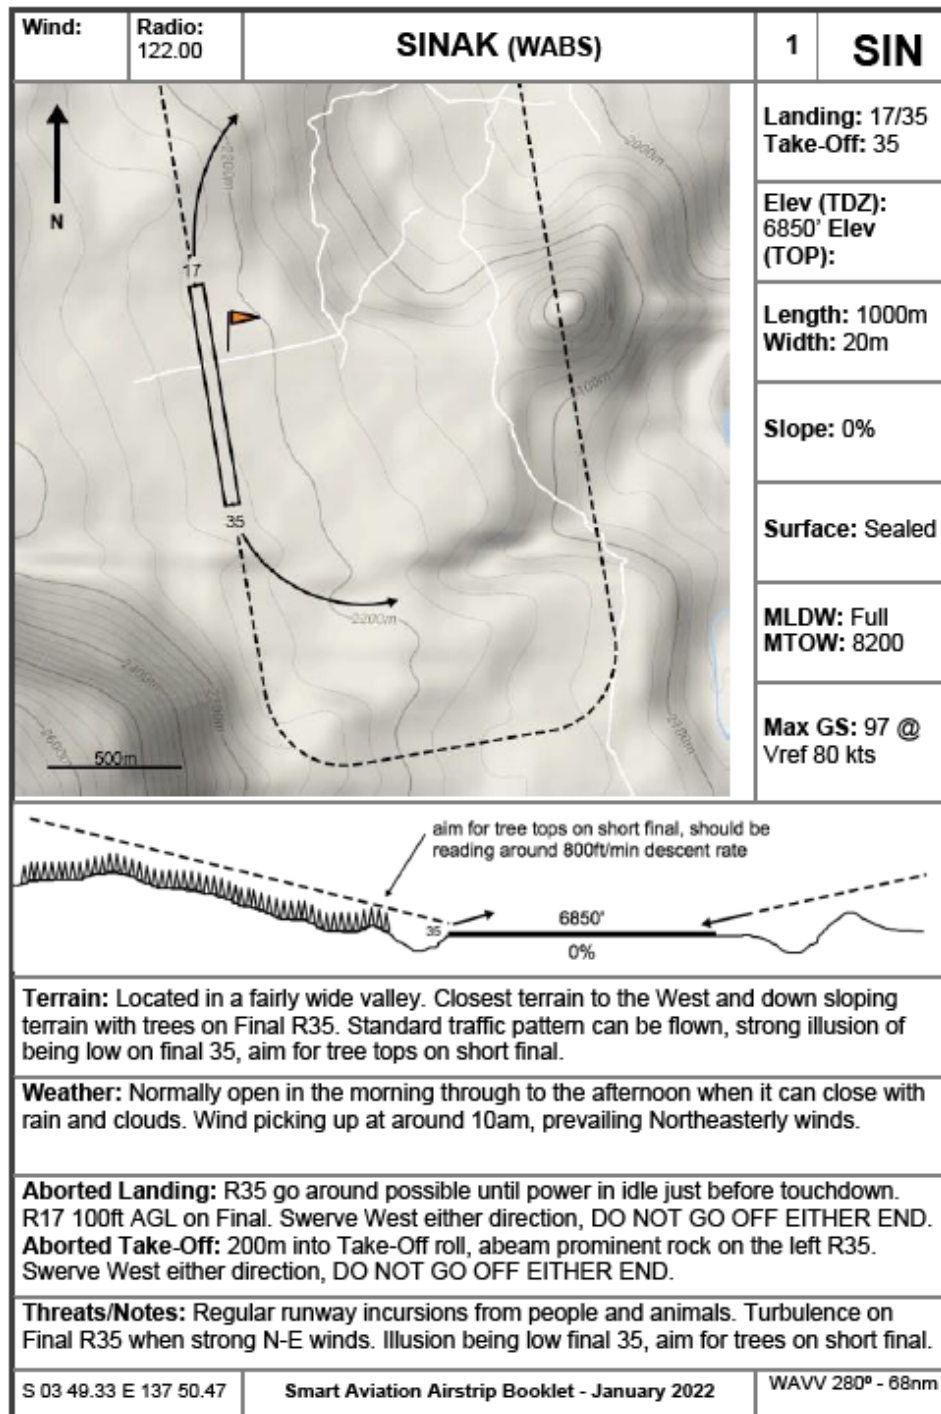
Figure 4: The Approach Chart of Sinak Aerodrome as stated in Smart Aviation Papua Airstrip Booklet

There was no ground-based navigation aid at Sinak. The aircraft operator developed an approach chart for Sinak, which included information about the area, routes, and aerodromes for internal use as follow:
