**KOMITE NASIONAL KESELAMATAN TRANSPORTASI  
REPUBLIC OF INDONESIA**

**Aircraft Accident Investigation Report**

**Cessna Caravan 208 B; PK-RVA**

**25 October 2022**

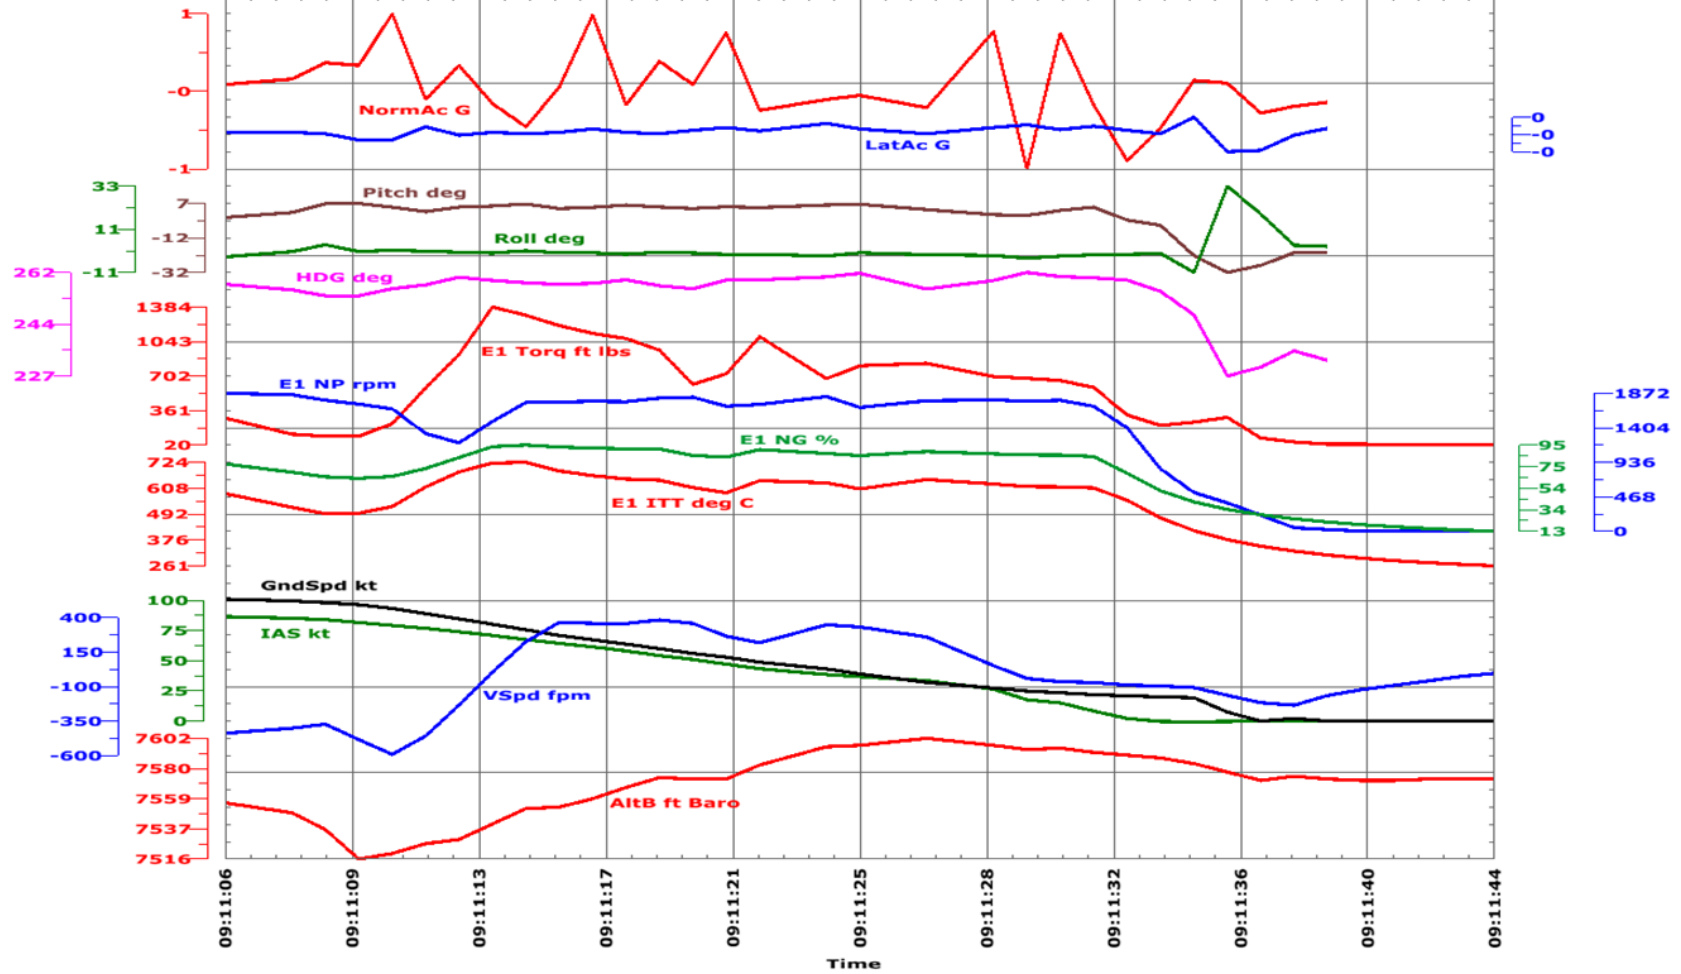
Figure 6: Relevant parameters recorded on the Garmin G1000 on the accident flight

The significant events from the flight data logging are as follows:

- a. the latitude and longitude,
- b. the increased engine torque beyond 1,000 feet pounds which indicates the activation of the reverse,
- c. the decreased engine torque below 1,000 feet pounds which indicates the deactivation of the reverse, and
- d. the point where the aircraft reduced speed for taxiing to the Ilaga apron.

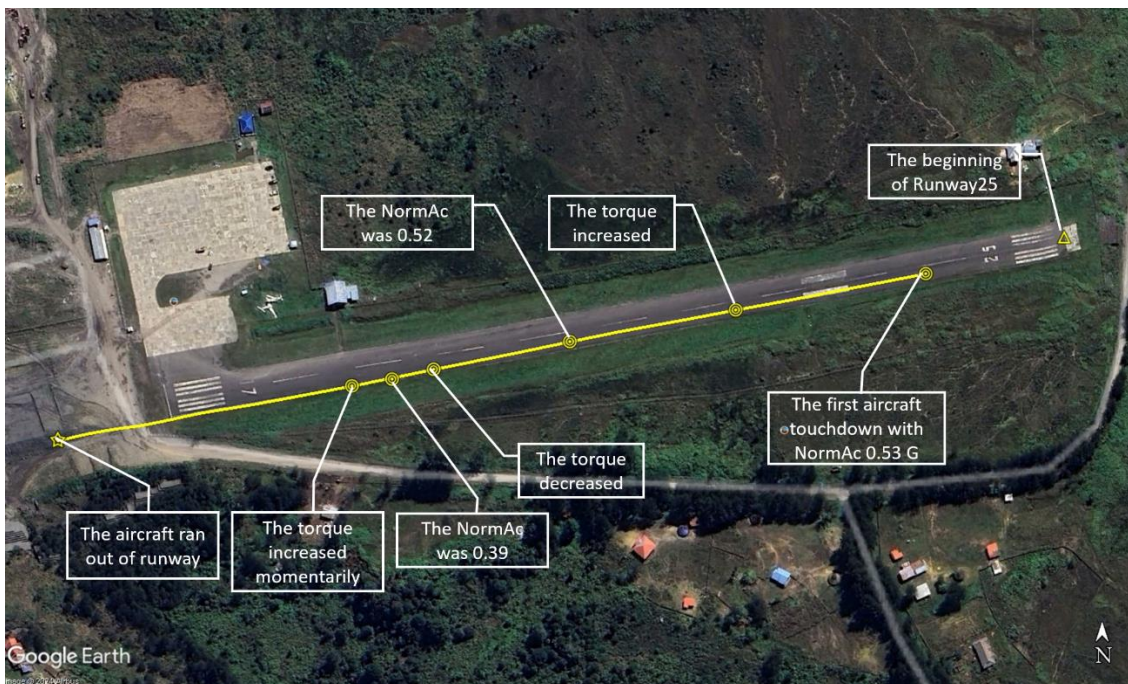
**Figure 10: The visualization of the aircraft landing on occurrence flight**

There was no marking found on the runway from the time the aircraft touched down until it exited the runway. The last position of the aircraft was about 77 meters beyond the runway.

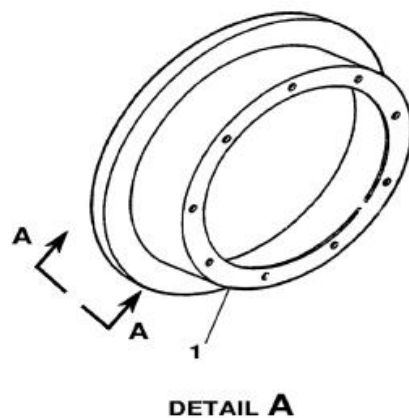
Disc brake measurements were conducted using a micrometer to determine the disc brake thickness, which was then compared with the requirements stated in the Aircraft Maintenance Manual (AMM). Measurements were taken at six different positions to obtain the average thickness. The minimum required thickness for the brake disc specified in the AMM, is 0.537 inches (equivalent to 13.64 mm). The average thickness of the brake disc was found to be below the minimum requirement. The detailed measurement results are shown in Table 1.
