**KOMITE NASIONAL KESELAMATAN TRANSPORTASI  
REPUBLIC OF INDONESIA**

**Aircraft Serious Incident Investigation Report**

**PT Semuwa Aviasi Mandiri**

**DHC6-300; PK-SMS**

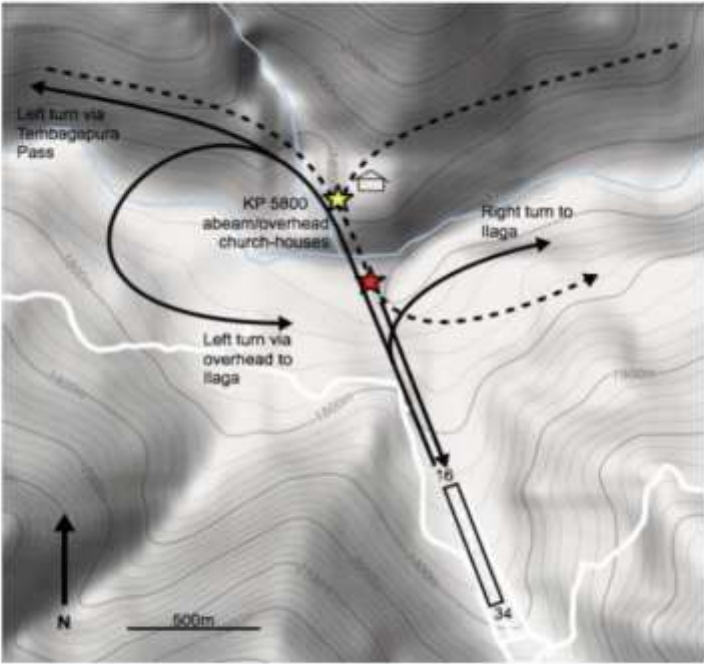
**Figure 5 Beoga Airstrip Information**

BEO	AIRSTRIP	MINIMA	RFFS	RUNWAY		RNY CAT	RADIO
	BEOGA	5800	N/A	TAKE OFF : 34	LANDING : 16	4	122
<b>LENGTH</b>	<b>WIDTH</b>	<b>TDZE</b>	<b>SLOPE</b>	<b>ELEVATION</b>	<b>KEYPOINT</b>	<b>GPS COORDINATE</b>	
500 m	25 m	5600 FT	12%	5600 FT	5800 FT	S 03 48.97 E 137 25.48	
<b>SURFACE</b>	: ASPHALT						
<b>OBSTACLE</b>	: High terrain all around. Situated in tight valley.

<b>ABORT LANDING</b>	: Just passing KP on final, left turn out. Straight off the upper end if unable to stop.						
<b>ABORT TAKEOFF</b>	: 10-25m into take-off roll, abeam the first electric pole. Continue straight off the low						
<b>WEATHER PATTERN</b>	: Normally good in the morning until midday then closing down with cloud and rain. Up-valley winds start picking up around 9am. Clouds can quickly form/disappear, monitor closely your escape plan in marginal VMC.
