# KNKT.23.05.05.04

**Aircraft Accident Investigation Report**

PT Marta Buana Abadi (Dimonim Air) Cessna C208; PK-HVG Yabi Airstrip, Papua Republic of Indonesia 9 May 2023

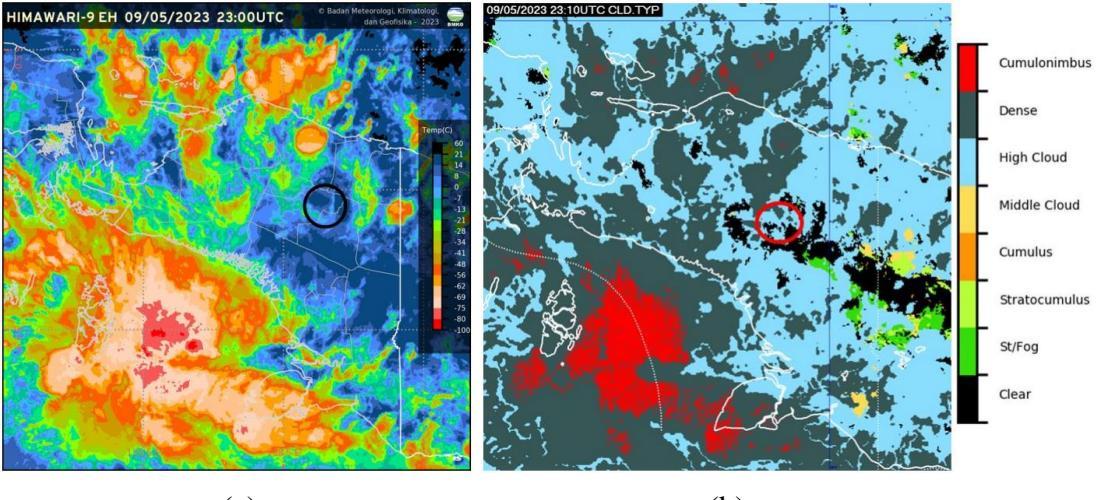
The IR Enhanced satellite imagery on May 9, 2023 at 2300 UTC around the accident area showed that the cloud top temperature ranged from  $0^{\circ}C - 14^{\circ}C$  as shown in Figure 1(a).

Meanwhile, the cloud type satellite imagery (HCAI Cloud Type) on May 9 2023 around the time of accident showed the presence of high clouds, and it was dominated by clear clouds as illustrated in Figure 1(b).
