**KOMITE NASIONAL KESELAMATAN TRANSPORTASI  
REPUBLIC OF INDONESIA**

**KNKT.23.05.09.04**

**Aircraft Accident Investigation Report**

**PAC 750 XL; PK-TET**

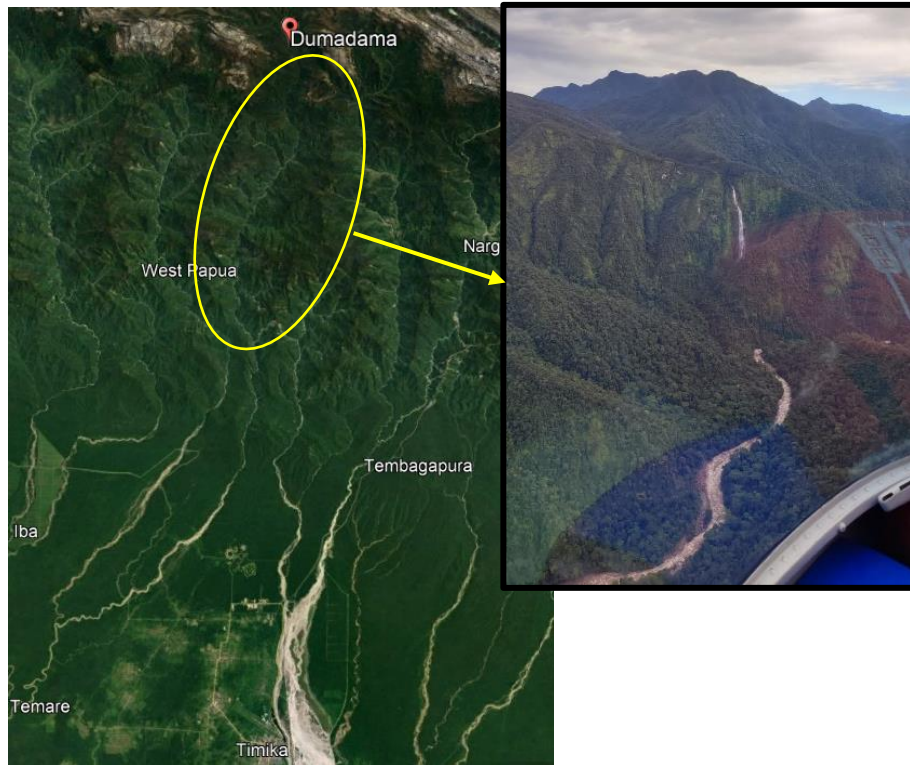
The PIC received the weather information from the flight operation officer (FOO) which consisted of the weather information of the departure point, Timika. Since there was no weather data available for Dumadama, the PIC determined the weather condition by observing the visibility of his checkpoint, which is a valley on the route to Dumadama. The illustration of the location and the view of the valley shown in Figure 7 and Figure 8. On the day of the occurrence, low ground fog was observed at the area of the checkpoint.

**Figure 7. Location and view of the valley (not representing the actual weather condition at the time of occurrence)**

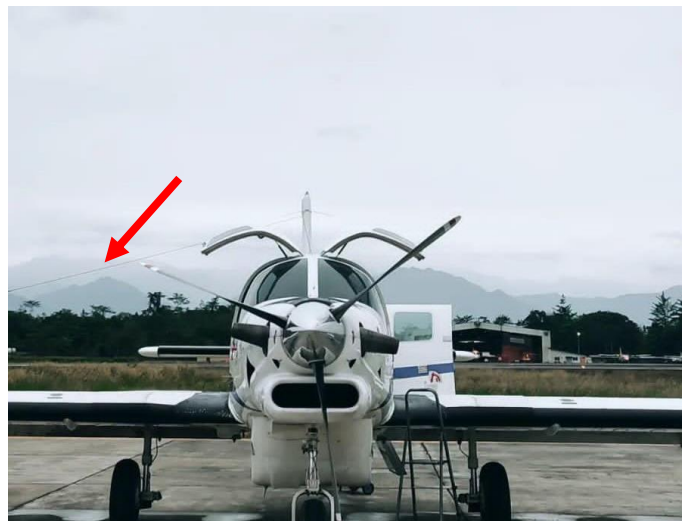
**Figure 8. View of the valley from Timika (not representing the actual weather condition at the day of the occurrence)**
