**KNKT 23.10.15.04**

**Aircraft Serious Incident Investigation Report**

**PT Smart Cakrawala Aviation**

**Cessna 208B EX; PK-SNI**

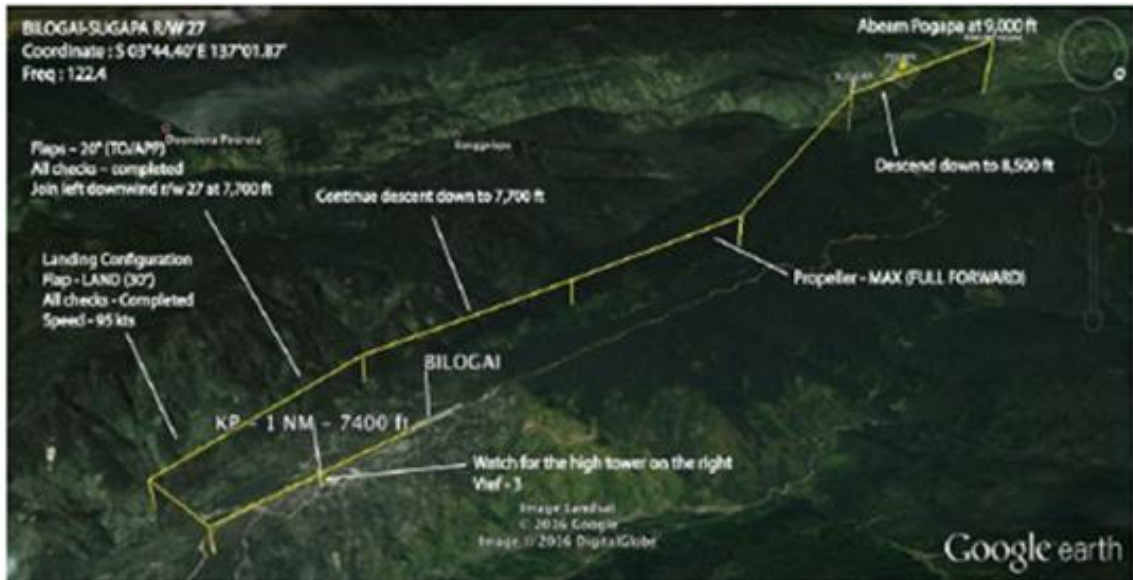
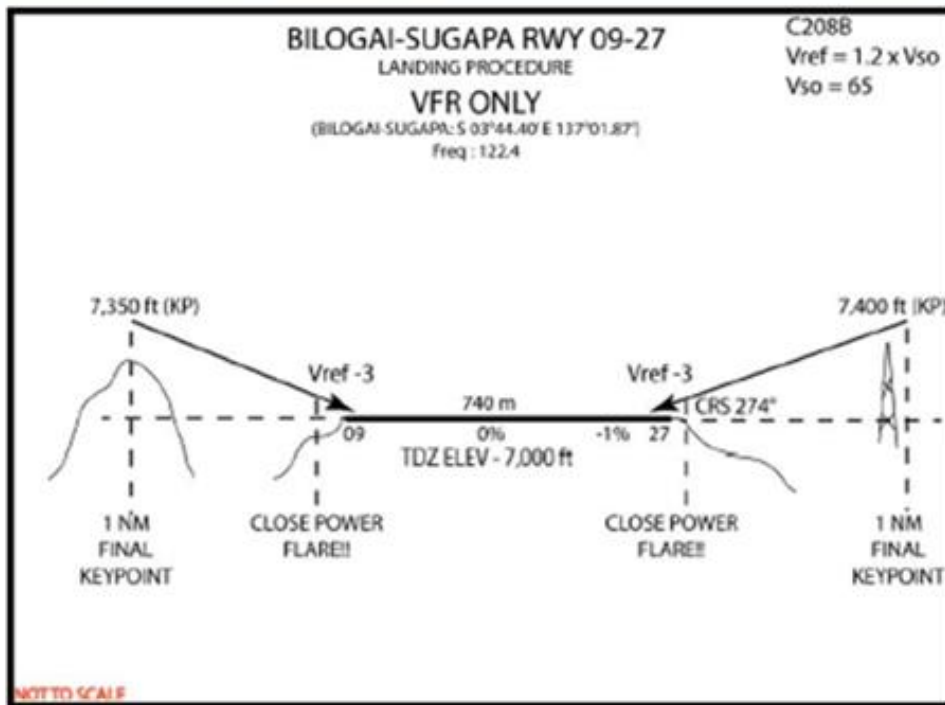
Figure 6: The approach path for Runway 09 and 27 of Bilorai Airport

The OM-C also described the approach path to the runway 09 and 27 of the Bilogai Airport as follow:
