**KOMITE NASIONAL KESELAMATAN TRANSPORTASI
REPUBLIC OF INDONESIA**

Aircraft Accident Investigation Report

Beechcraft Baron G58; PK-LRV

5 October 2023

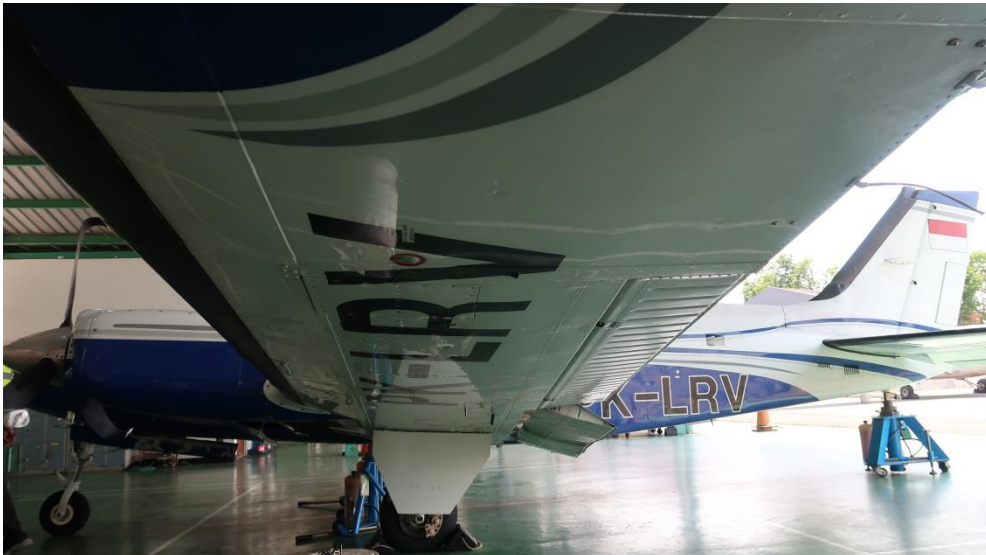
Figure 9: The aircraft on jacks

1. The engineers conducted a visual inspection of the aircraft to ensure that the up and down check would not result in further damage.
2. The aircraft was put on hydraulic jacks. Two hydraulic jacks were placed under each wing root and one jack was placed on the aircraft tail.
3. The jacks were extended until the aircraft was lifted off the ground.

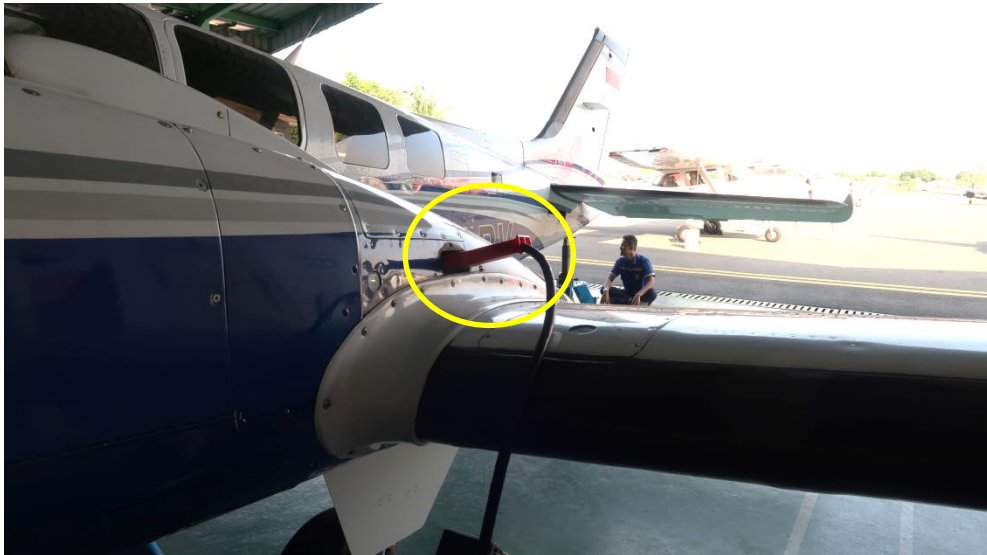
Figure 10: The yellow circle showed the external power source was attached to the aircraft
