**KOMITE NASIONAL KESELAMATAN TRANSPORTASI  
REPUBLIC OF INDONESIA**

**Aircraft Accident Investigation Report**

**Bell 429; PK-WSW**

**20 February 2024**

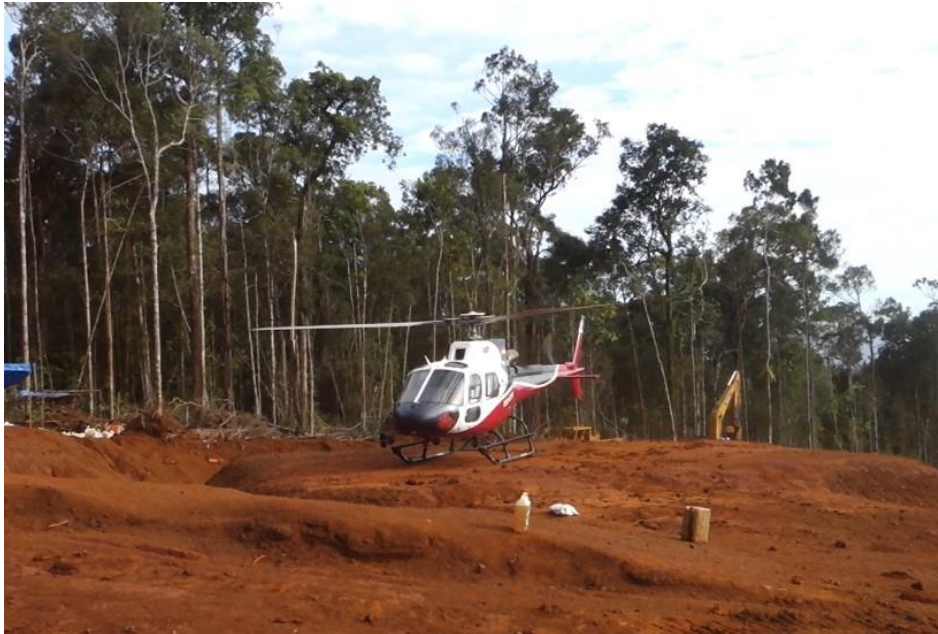
**Figure 3: The Pinto East Helipad with another helicopter landed on it**

Before the accident, the helicopter departed from the Pinto East Helipad. The Pinto East Helipad was located at the coordinate of 0° 35' 49.7" N; 128° 6' 43.3" E in an elevation of 2,700 feet above mean sea level with a distance of about 9 Nm at a radial of 120° from the Kaorahai helipad. The Pinto East Helipad situation was shown in the figure below.

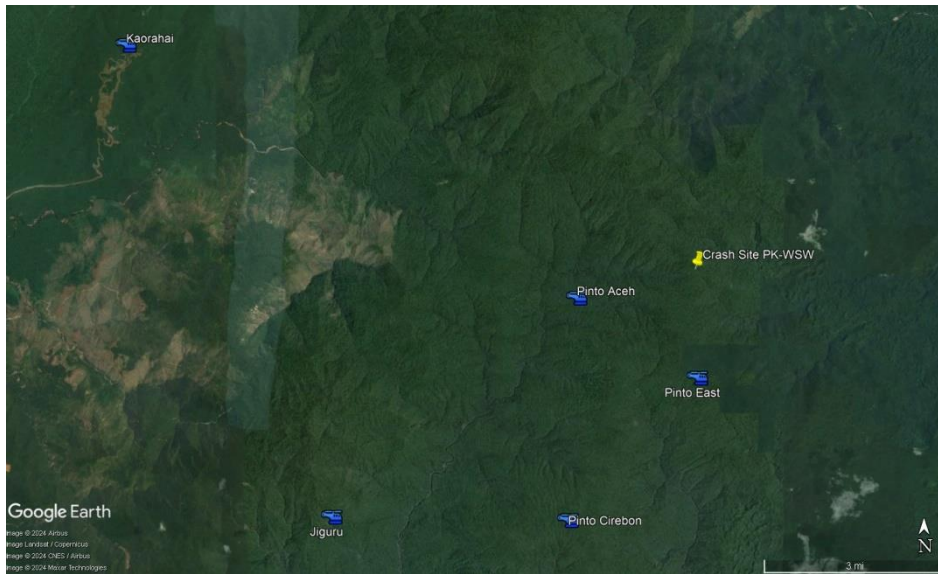
**Figure 4: The helipad location and the crash site information**

The helicopter wreckage was found in the rain forest at a coordinate of 00° 37' 19.9" N; 128° 06' 30.6" E at an elevation of about 2,900 feet above mean sea level and about 1.5 Nm on radial 350° from Pinto East helipad. The crash site location in the Google Earth application is shown in the figure below.
