**KOMITE NASIONAL KESELAMATAN TRANSPORTASI  
REPUBLIC OF INDONESIA**

**KNKT.24.03.08.04**

**Aircraft Accident Investigation Report**

**Pilatus PC-6/B2-H4; PK-SNE**

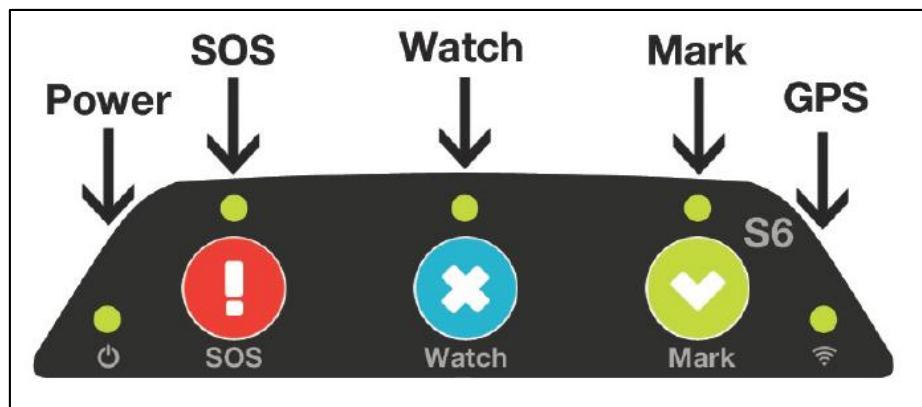
**Figure 1: Spider 6 keypad**

The Spider Tracks installed in the aircraft utilized a keypad with three different functions (Figure 1).

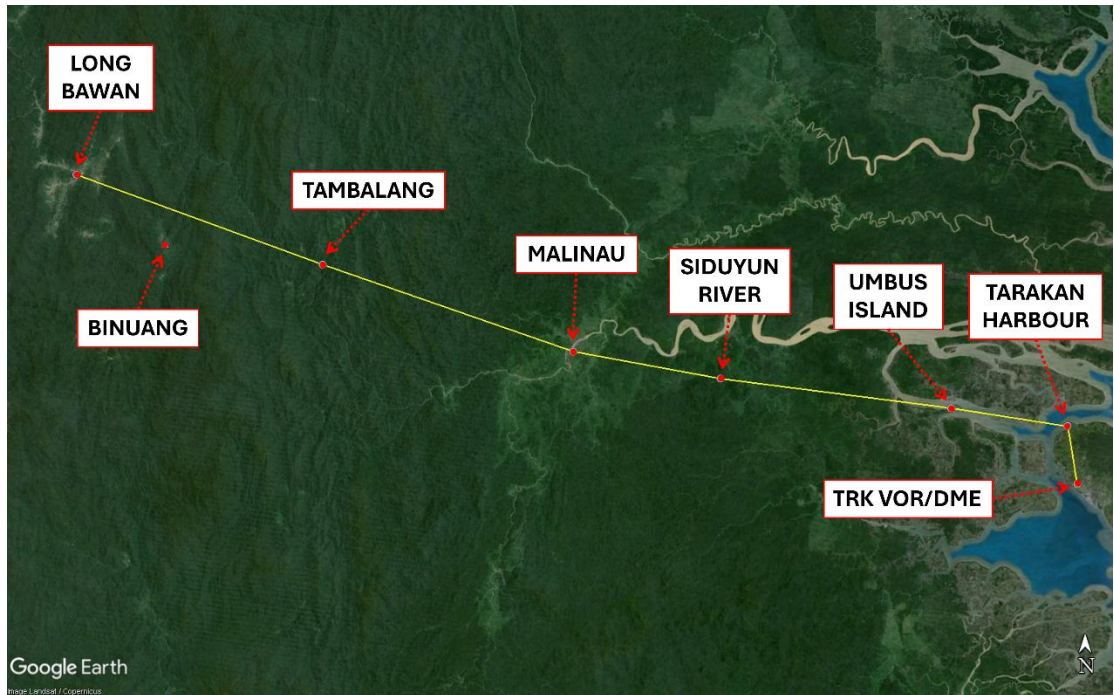
**Figure 7: Illustration of the VFR route from Tarakan to Long Bawan**

The AIP Volume I Subchapter ENR 6-1J provided VFR routes for North and East Kalimantan. The route for a flight from Tarakan to Binuang was not included. The

following figure is an illustration of the VFR route from Tarakan to Long Bawan based on the AIP with the location of Binuang.

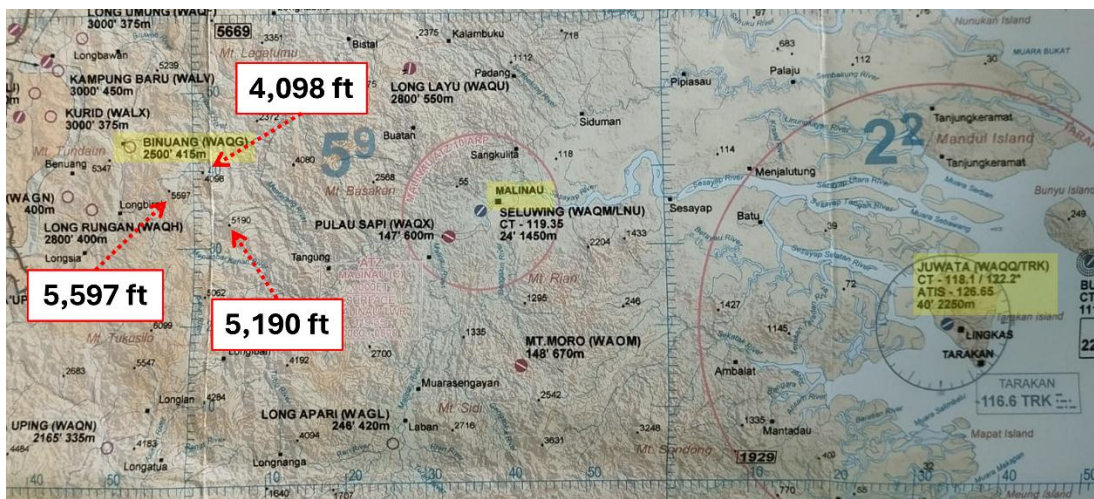
Figure 10: Cropped INDOAVIS ONC annotated and highlighted by KNKT

Smart Aviation provided the Operation Navigation Chart (ONC) of the Northern Kalimantan Area (Indonesia, Malaysia, and Brunei) on board the aircraft and at the Tarakan flight operation office. The ONC was published by INDOAVIS, an Indonesian aeronautical information provider, with a scale of 1:1.000,000. The cropped ONC, which showed the Binuang, was as follow:

Smart Air provided the Operation Navigation Chart (ONC) of the Northern Kalimantan Area (Indonesia, Malaysia, and Brunei) on board the aircraft and at the Tarakan flight operation office. The ONC contained terrain information near Binuang (see figure 10 in Subchapter 1.8).
