**KNKT.24.05.011.04**

**Aircraft Accident Investigation Report**

**Tecnam P2006T; PK-IFP**

**19 May 2024**

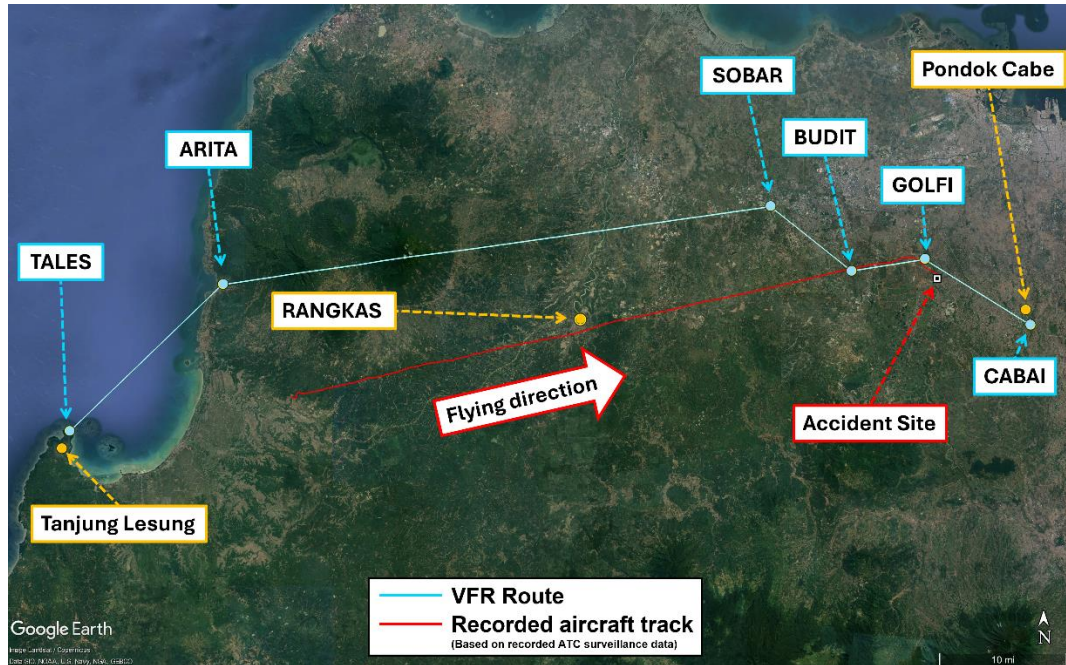
**Figure 4: The VFR route guide and recorded aircraft flight track**

At 1329 LT, Jakarta ACO contacted PK-IFP pilot and requested estimated time over waypoint BUDIT, and was responded that the estimated time would be 1340 LT. The pilot also advised Jakarta ACO that the estimated time arrival at Pondok Cabe would be 1356 LT. Jakarta ACO then instructed the pilot to report when the aircraft was flying over Waypoint BUDIT. The pilot acknowledged and informed that after flying over Waypoint BUDIT, the aircraft would fly to Waypoint GOLFI.

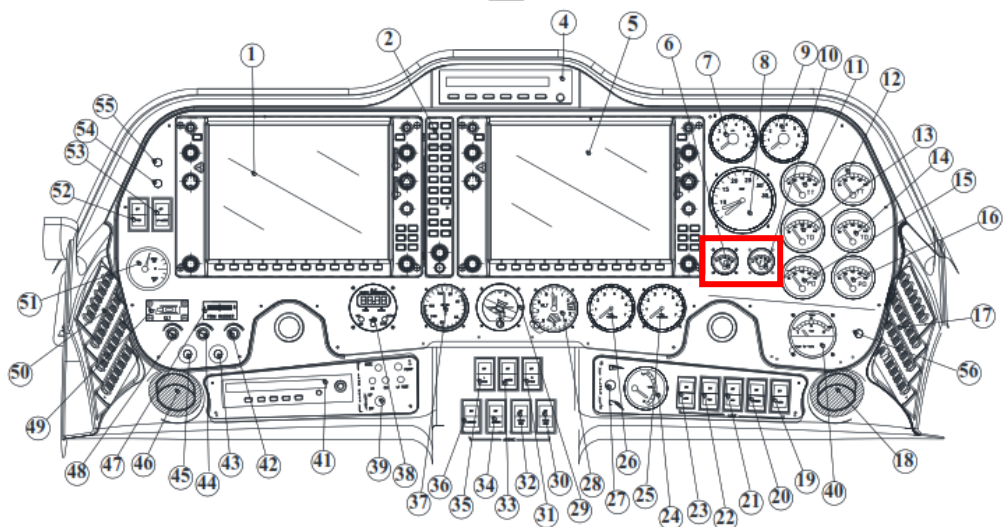
**Figure 6: The location of fuel quantity indicators (red-highlighted)**

According to the Tecnam P2006T AFM, the aircraft has fuel quantity indicator for each fuel tank respectively, which was located on the right instruments panel.

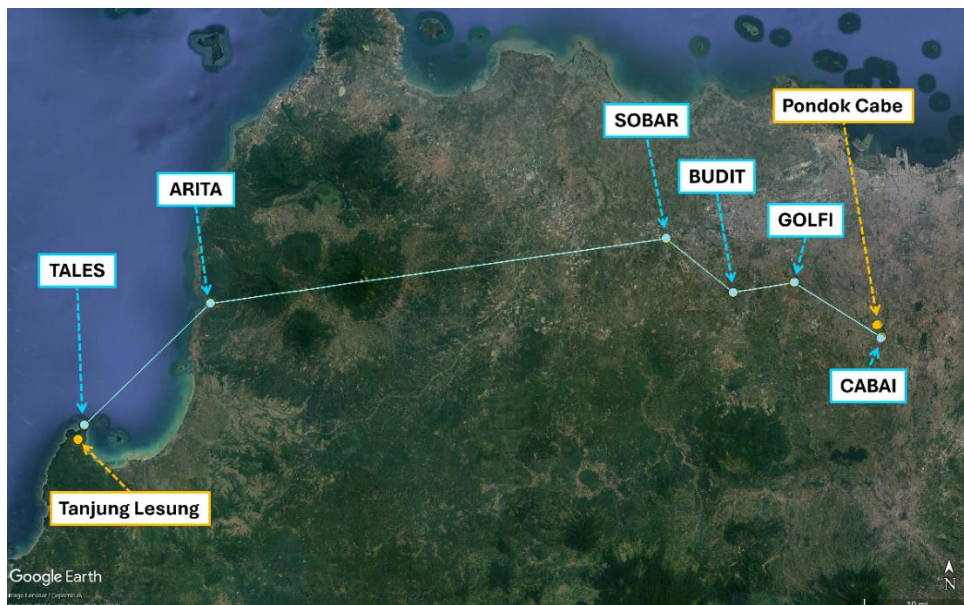
Figure 8: The available VFR route from Tanjung Lesung to Pondok Cabe

The Indonesia **Aeronautical Information Publication** (AIP) Volume I Subchapter ENR 6-1D provided VFR Route for Jakarta and North Java Area. The VFR route from Tanjung Lesung to Pondok Cabe consisted of several waypoints as depicted in the following figure.

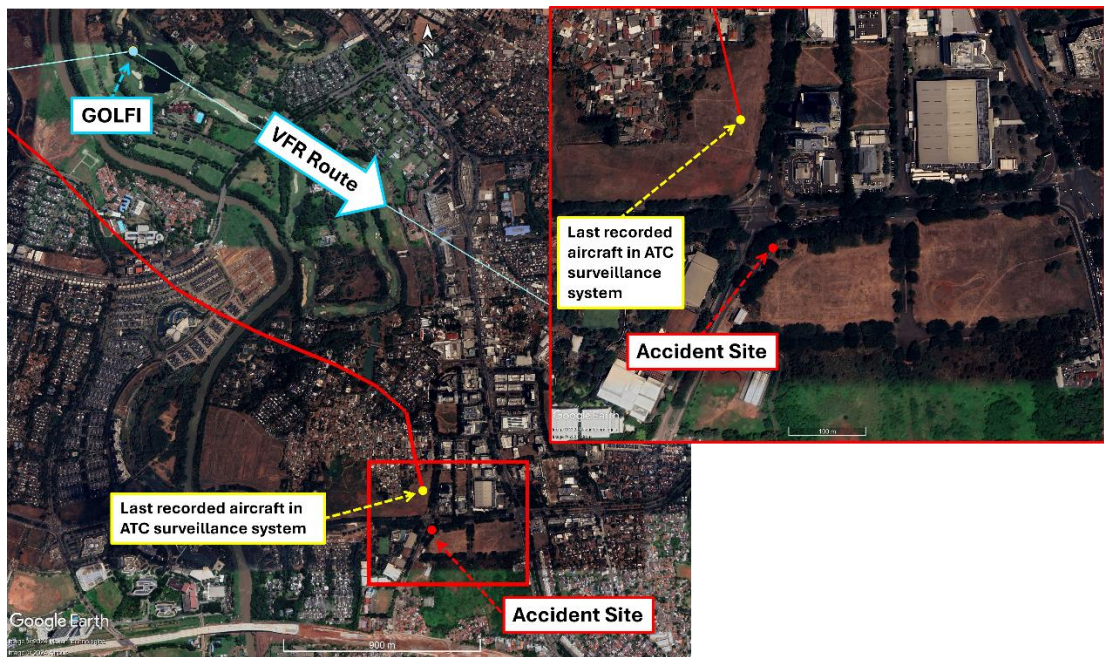
**Figure 9: The flight track and accident site (based on ATC surveillance system and imposed to Google Earth)**

The aircraft wreckage was found on coordinate  $6^{\circ}18'0.49''S$   $106^{\circ}39'50.71''E$ , which located about 1.5 NM from Waypoint GOLFI on a bearing of  $146^{\circ}$  with an elevation about 88 feet. The accident site was located near an open field.

The aircraft collided with trees then impacted the ground with the estimated impact angle of  $40^{\circ}$ . The aircraft stopped across the street from the first impact point.

The right engine detached from its engine bay and was found about 7 meters on the left side of the first impact point. The left horizontal stabilizer and right-wing tip was found near the first ground impact point. At the accident site, there was smell of fuel.
