**KOMITE NASIONAL KESELAMATAN TRANSPORTASI
REPUBLIC OF INDONESIA**

Aircraft Accident Investigation Report

PT Whitesky Aviation

Bell 505; PK-WSP

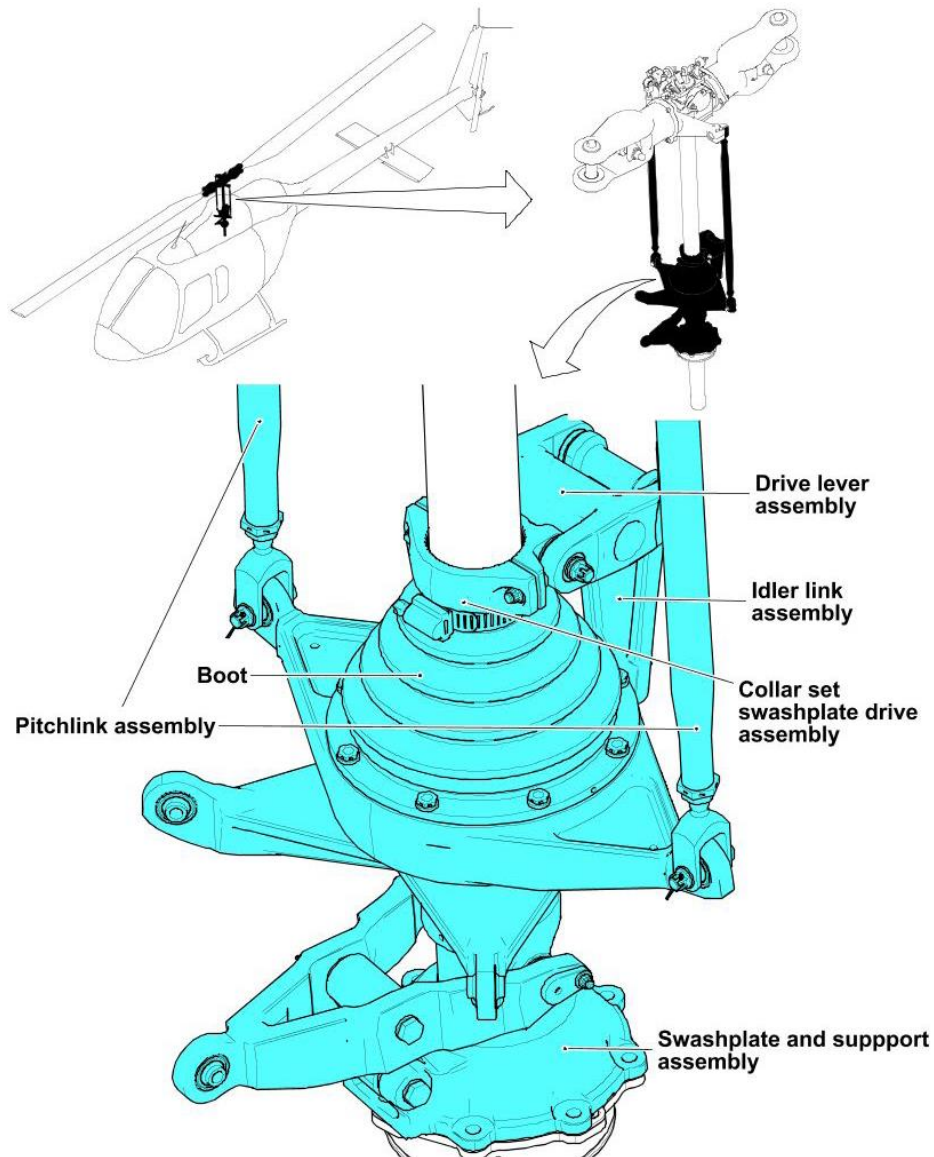
Figure 3: The Pitch link assembly

The main rotor pitch link assembly is the part of the primary flight control that allows the pilot to fly the helicopter in any direction of travel: forward, rearward, left, and right. Any disturbance of the pitch link assembly in-flight required the pilot to land as soon as possible, as the pilot would not be able to control the helicopter.

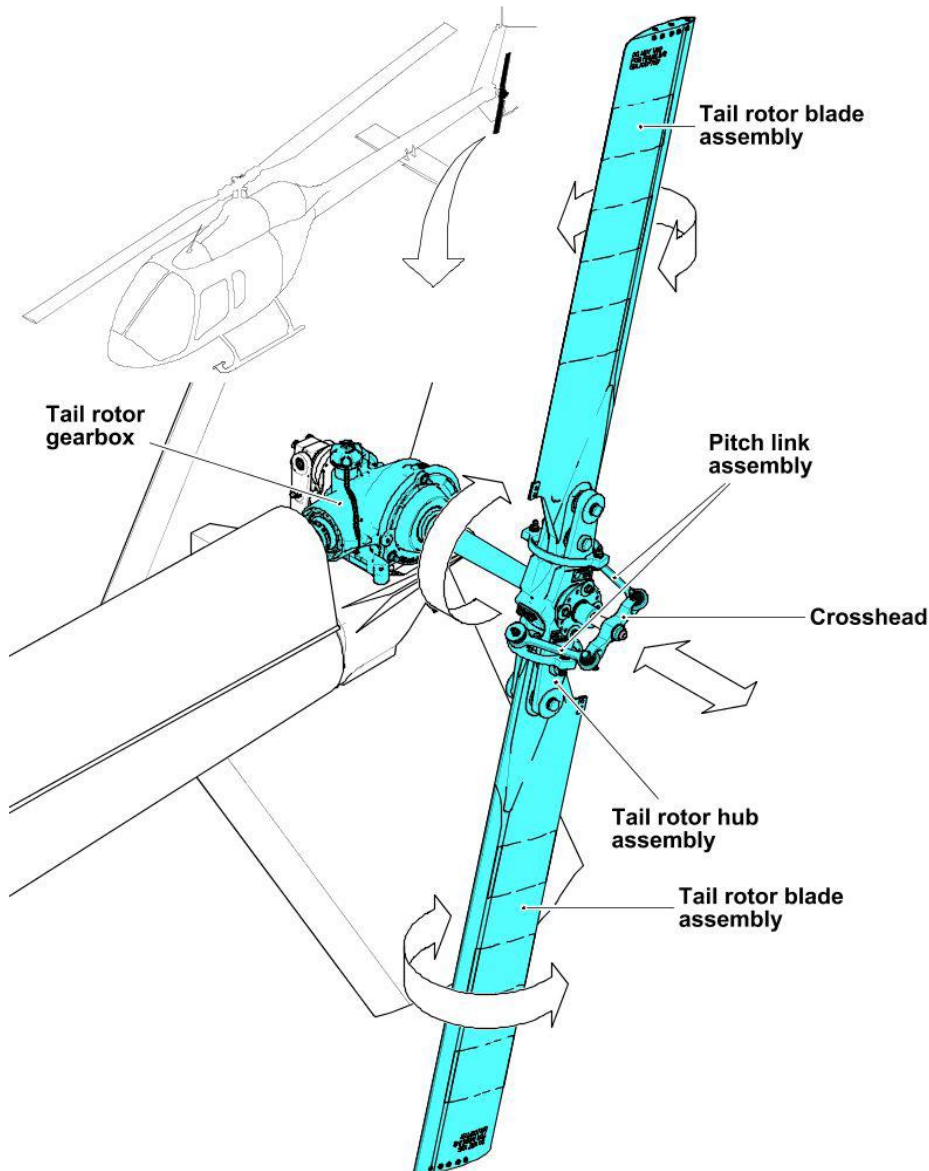
Figure 4: The tail rotor assembly

The tail rotor pitch link assembly is also part of the primary flight control that allows the pilot to control the torsional effect of the helicopter by applying the pedals. Any disturbance of the tail pitch link assembly in flight might result in the loss of tail rotor effectiveness and require the pilot to land as soon as possible, as the pilot would not be able to control the helicopter.

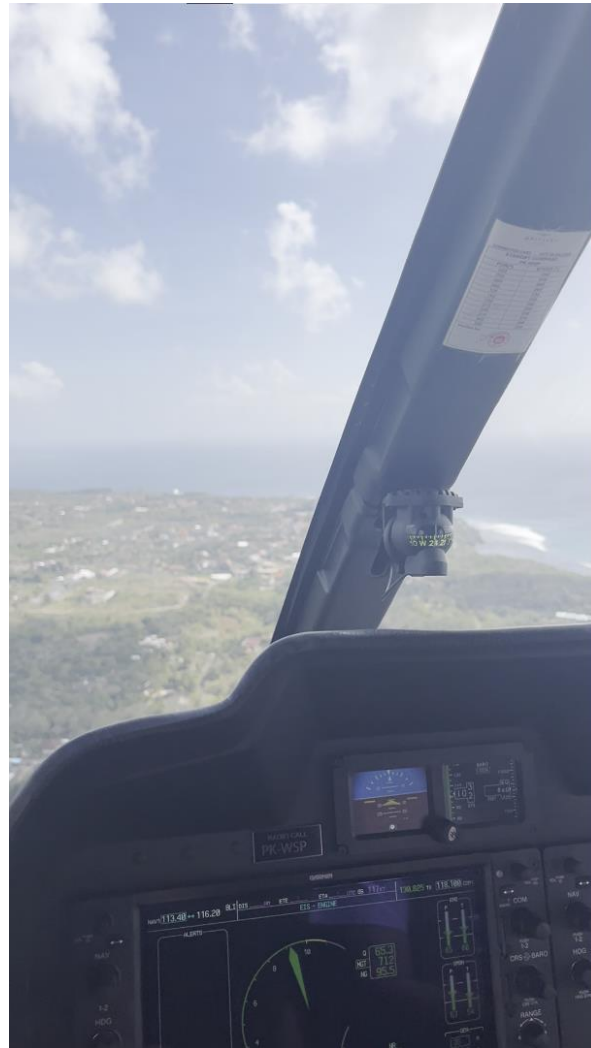
Figure 13: Recorded video at 14:35:58 LT

1. At 14:35:58 LT, the helicopter at altitude about 800 feet on heading towards the accident site (Figure 13).
