**KOMITE NASIONAL KESELAMATAN TRANSPORTASI
REPUBLIC OF INDONESIA**

KNKT.24.10.22.04

Aircraft Serious Incident Investigation Report

Boeing 737-800; PK-GMP

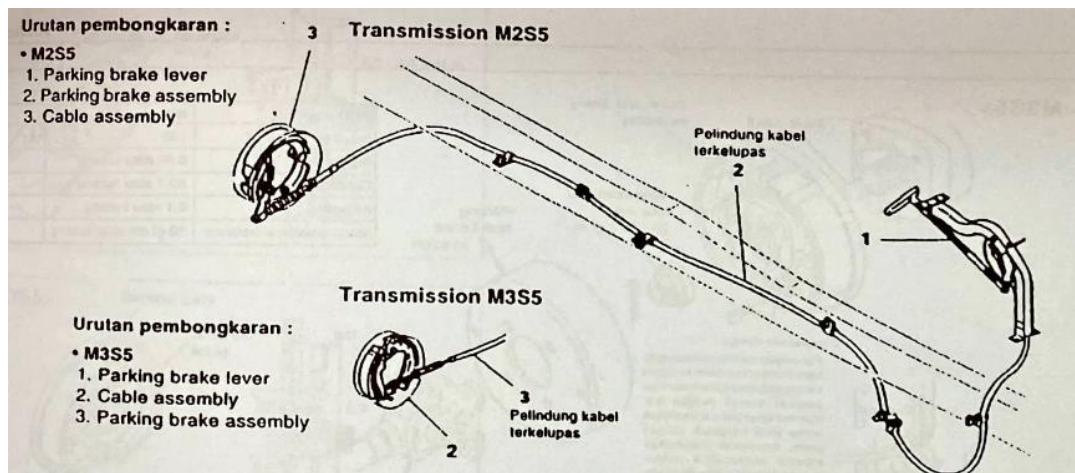
Figure 5: Typical mechanism and schematic control of the parking brake installed in the LST

The truck's parking brake system is controlled from the cabin by a ratchet-bar handle connected via a cable to the brake drum. The brake drum is installed on the propeller shaft, which connects the transmission gearbox and rear gearbox to the aft wheel. The following picture describes the typical mechanism and schematic control of the parking brake installed in the truck.

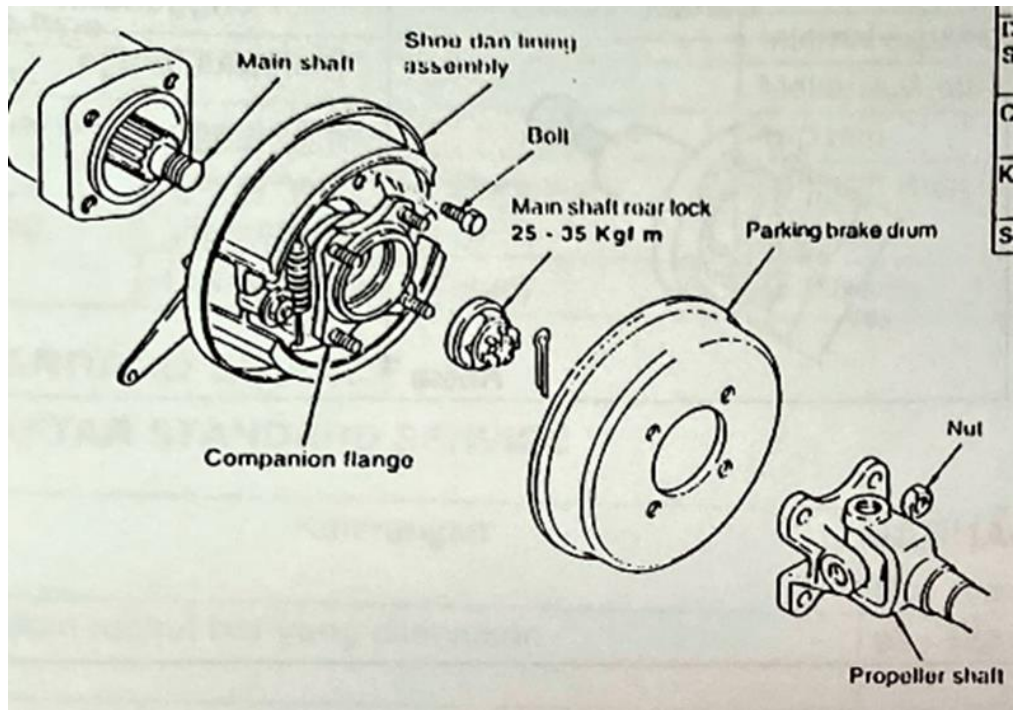
Figure 6: Components of the parking brake drum

unknown. The replacement or reinstallation of the brake shoe and lining was not performed until the occurrence due to the unavailability of the replacement parts.
